FINAL FLOOD REDUCTION INVESTIGATION FOR LAKE McMURRAY, HULL DRIVE & HULL ROAD

Prepared for:
Skagit County Public Works
1800 Continental Place
Mount Vernon, WA 98273

Prepared by:
  **WATERSHED**
SCIENCE & ENGINEERING
506 2nd Avenue, Suite 2700
Seattle, WA 98104
206-521-3000

January 7, 2021

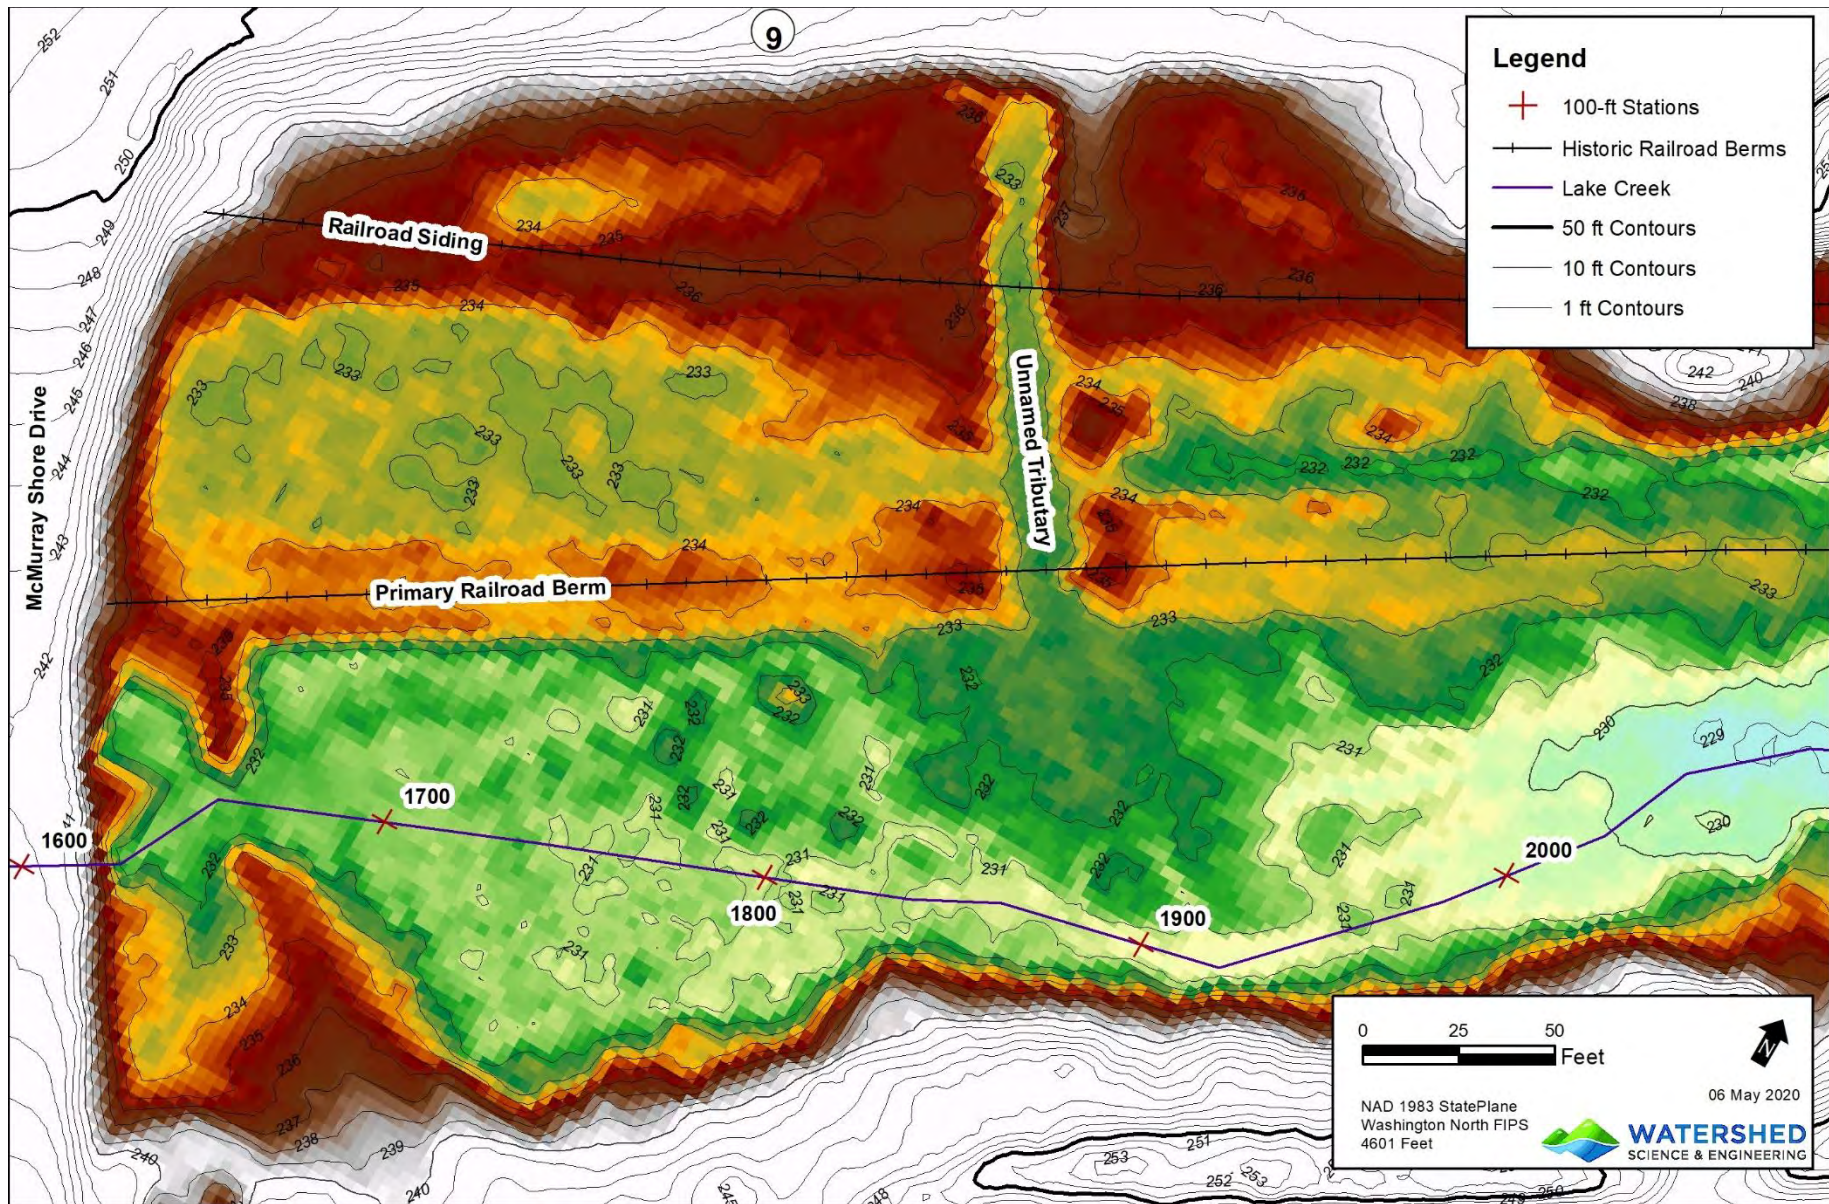
Figure 5. Lower Reach Topography near unnamed tributary to Lake Creek.

Figure 5 and Photo 13 show an unnamed tributary entering the lake outlet channel approximately 300 feet downstream of McMurray Shore Drive. After crossing under SR9 through a culvert, the unnamed tributary passes through both the abandoned railroad siding and the primary railroad berm before reaching Lake Creek. The tributary has created a large sediment delta at the confluence with Lake Creek. (The delta is the dark green feature at the confluence in Figure 5.) The delta partially obstructs flow because it rises 12 to 18 inches above the natural valley floor; however, it is not a complete barrier for it likely is overtopped by Lake Creek during major floods. The delta also constricts the outlet channel by pushing Lake Creek against the southeast valley. It is likely that the delta is one of the primary features obstructing the outlet channel, a finding that was also identified by Anchor QEA during their 2010 investigation of the outlet channel (Anchor, 2010).

Downstream from the unnamed tributary, Lake Creek meanders through a valley floor covered with thick vegetation. Throughout the reach there is evidence of beaver activity but no significant dams until station 3,700 feet. Here there is a large beaver dam to the left (northwest) of the primary railroad berm. The dam is not obstructing the outlet channel because it is on the opposite side of the berm from the stream.

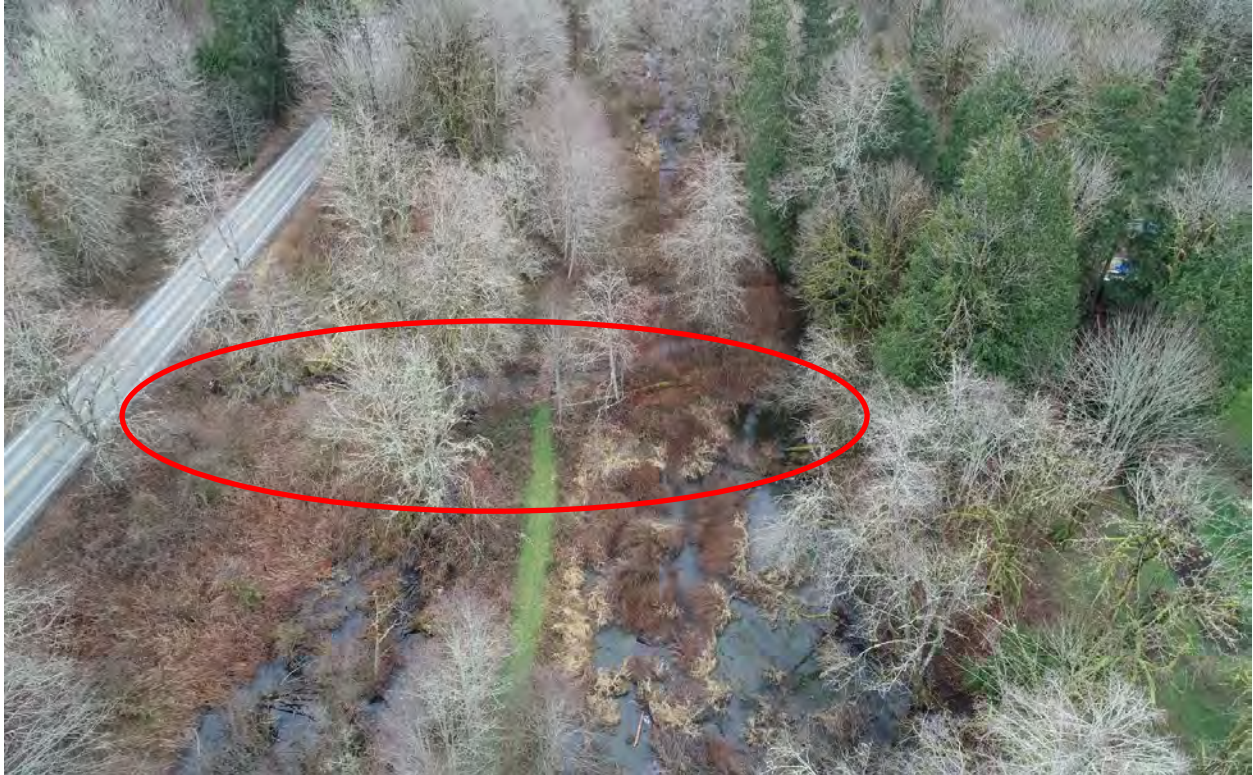
Photo 8. Looking downstream from McMurray Shore Drive. SR9 is on the left side of the photo. The green strip down the center of the photo is the top of the mainline abandoned railroad berm. The unnamed tributary is circled in red. (March 10, 2020).

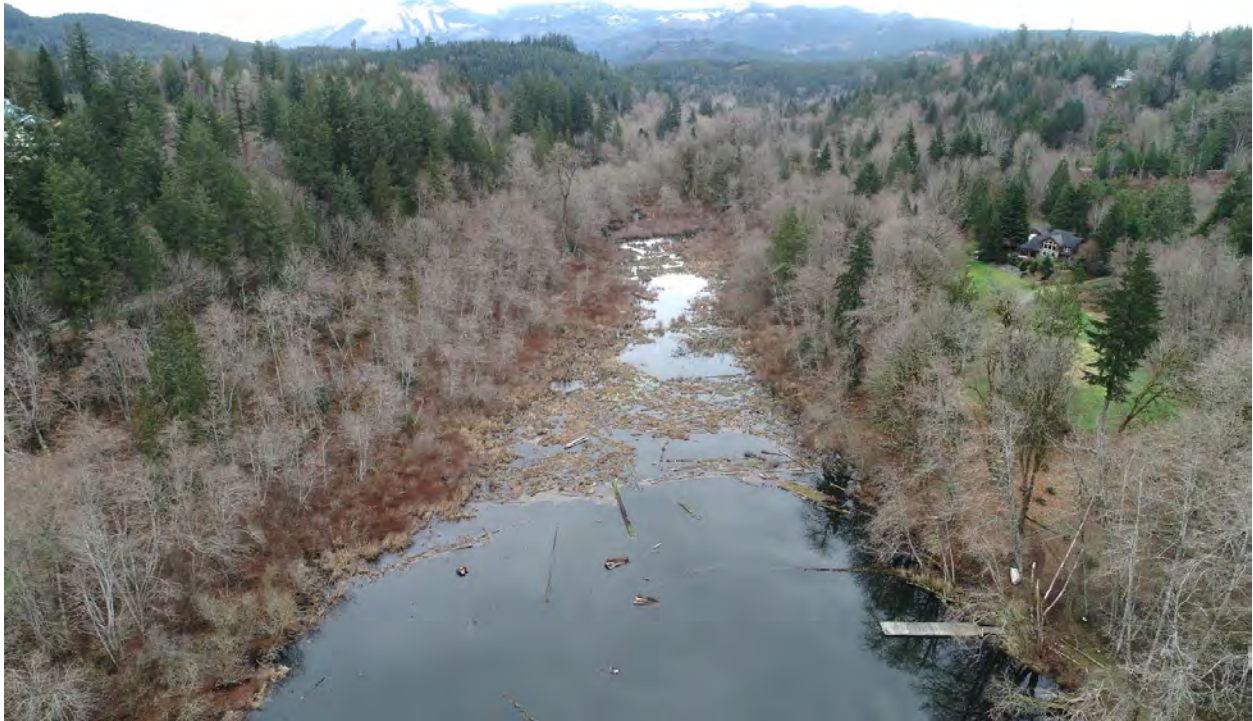
In addition to the beaver deceivers, thick vegetation and lots of woody debris were observed in the channel upstream of McMurray Shore Drive (Photo 2). This roughness in the channel would be expected to impede flow and slow drainage of the lake during and after a storm event, but did not appear to be the major control on lake levels.

Photo 2. Drone aerial looking downstream from Lake McMurray into the outlet channel (Photo taken March 10, 2020).

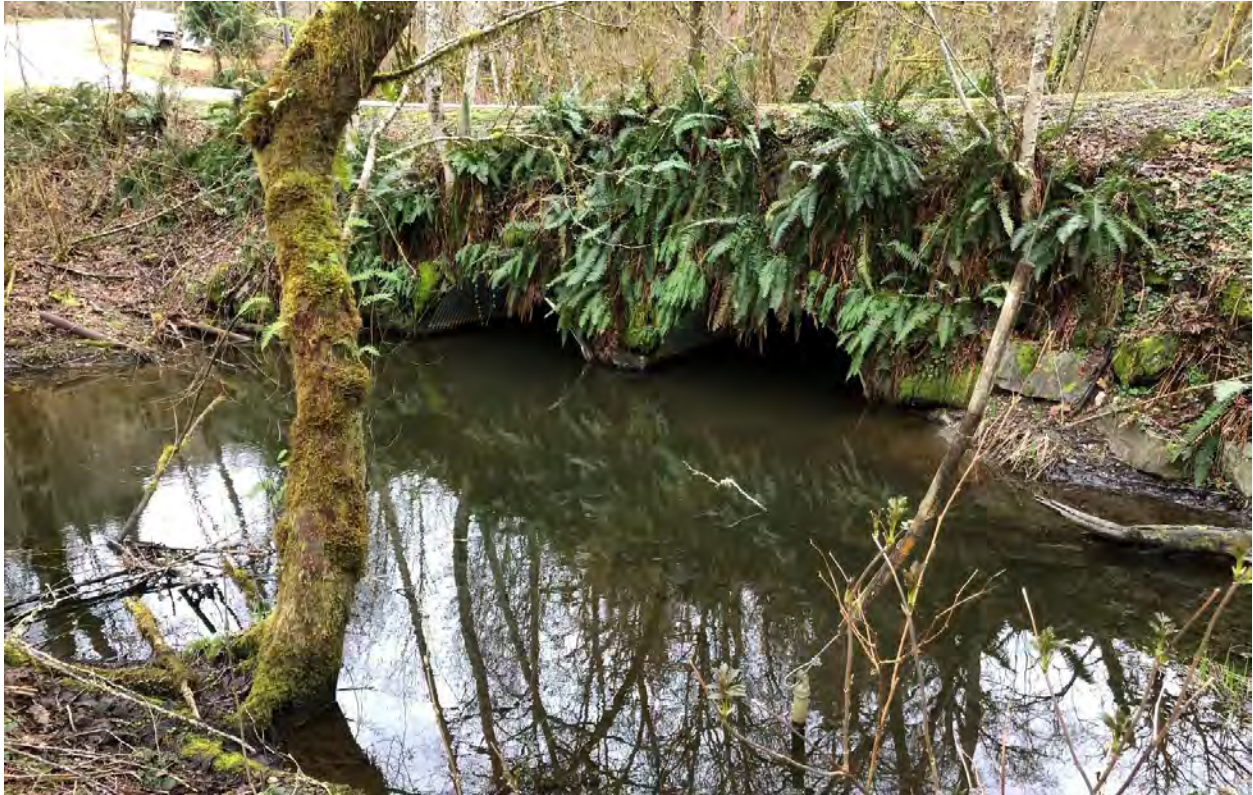
Moving downstream, approximately 21 inches of ponded water was observed within the culverts under McMurray Shore Drive during the February 2020 site visit (Photo 3). This also indicated that something downstream of the culverts and not the culverts themselves were controlling lake level.

Photo 3. Outlet of existing dual culverts under McMurray Shore Drive.

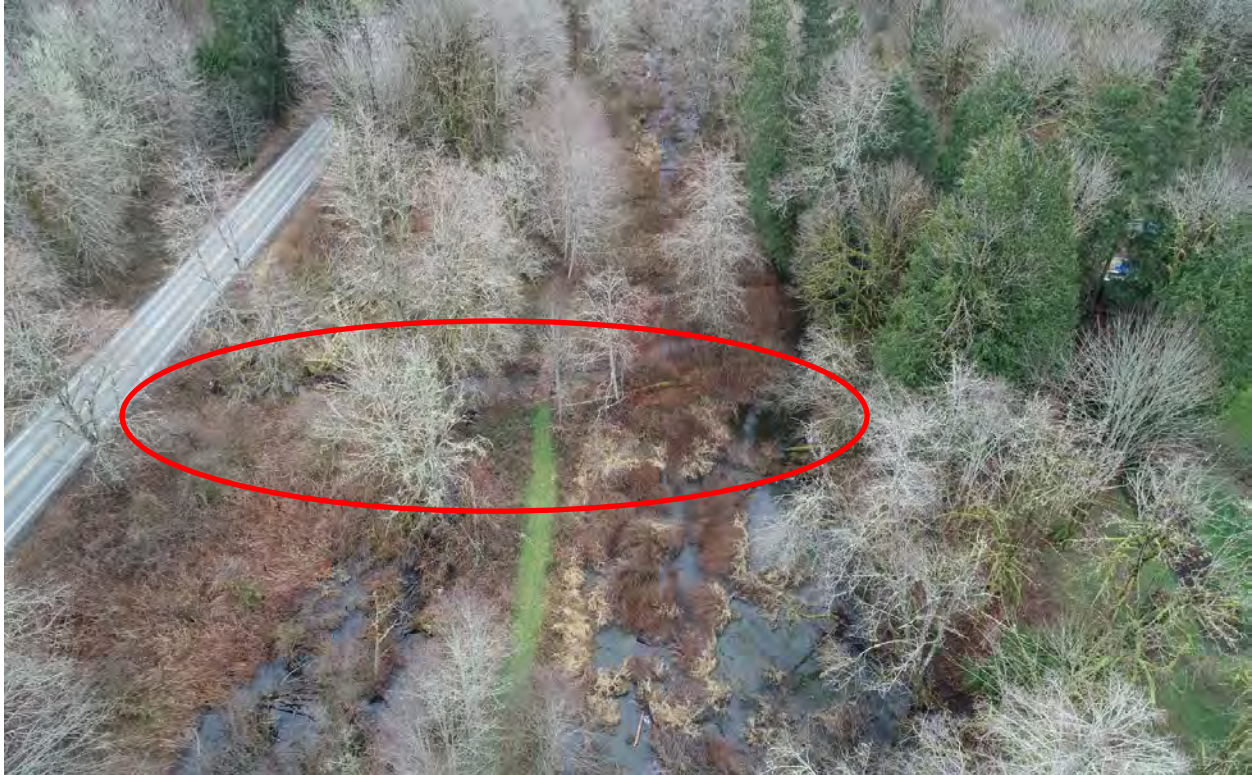
Approximately 300 feet downstream of McMurray Shore Drive, WSE observed a small unnamed tributary which empties into Lake Creek after passing through a culvert under SR 9 (see Figure 3 and Photo 4). This unnamed tributary has deposited sediment at its confluence with Lake Creek, creating a sediment delta that constricts the channel width and therefore flow in Lake Creek. Upstream of this point water appears ponded. Downstream of this point water begins flowing freely again. This would indicate that this constricted channel section is controlling lake water levels during low flows and we suspect that it is at least partly responsible for increased lake levels during storm events.

Photo 4. Looking downstream from McMurray Shore Drive. SR9 is on the left side of the photo and the unnamed tributary is circled in red. (March 10, 2020).

Based upon the model results, it is WSE’s opinion that beaver dams pose the greatest risk to lake levels. If beavers reoccupy the lake outlet channel, an aggressive beaver dam management program will be required to maintain lake outlet flow. Vegetation removal/management combined with partial excavation of the unnamed tributary delta would be an improvement; however, if these improvements increase velocities in the outlet channel, beavers may reoccupy the reach. Due to the history of beaver dams in this location and the fact that beavers are currently very active just a short distance downstream, increasing the velocity will likely be met by new beaver activity. Removing portions of beaver dams and/or relocating beavers can be difficult for it requires state permits and significant time, energy and money to do effectively. Full removal of the delta and excavation of the channel combined with vegetation removal/management would provide a significant improvement, however it will likely be difficult to permit. If the partial or full delta alternative is selected, a sediment basin immediately downstream from the SR9 culvert should be included to extend the life of the delta excavation.

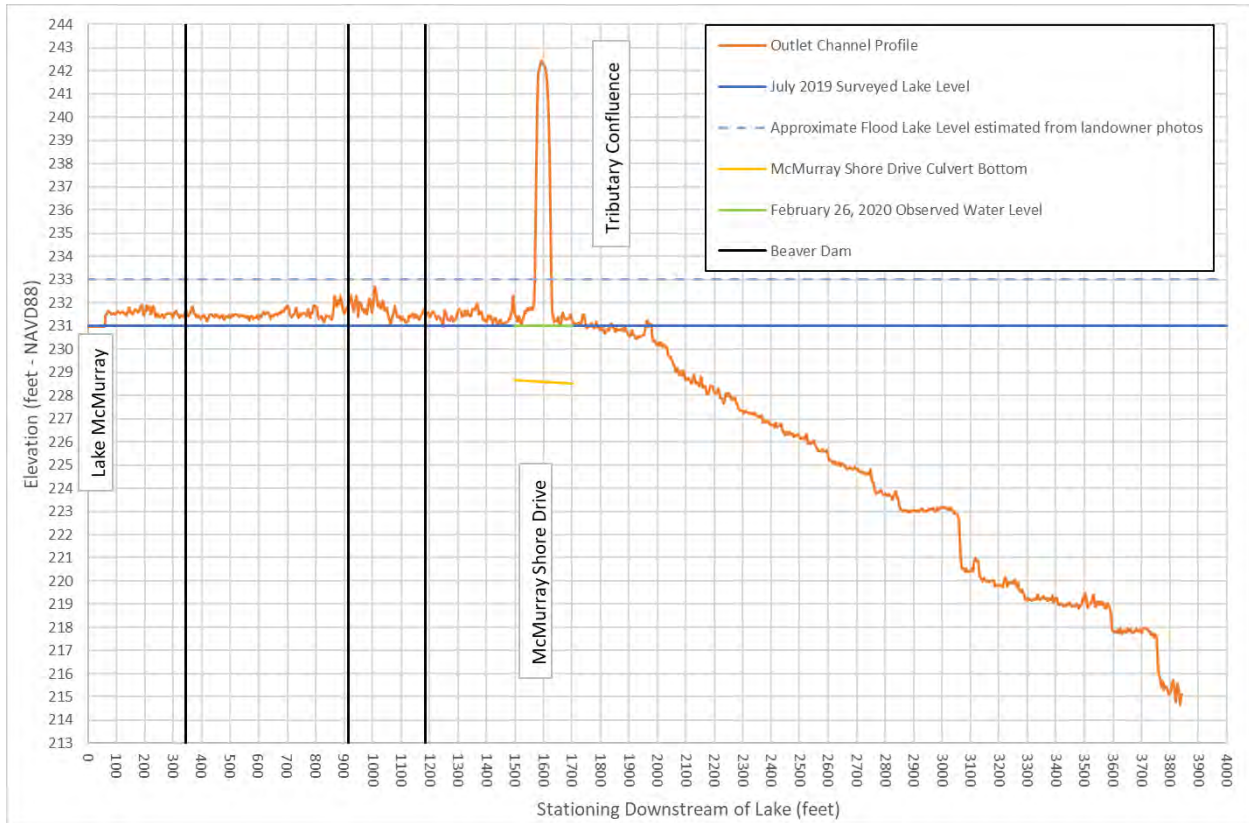
Figure 4. Lake Creek profile downstream of Lake McMurray outlet.

Inspection of the 2017 LiDAR data also revealed that water levels remain nearly flat from the lake to McMurray Shore Drive (Figure 4). The slope of the water surface then increases slightly (0.002 feet/foot) along the first 300 feet downstream of McMurray Shore Drive, then steepens significantly along the remainder of the profile (0.008 feet/foot). It is this flat section of the stream that is having difficult time draining the lake.

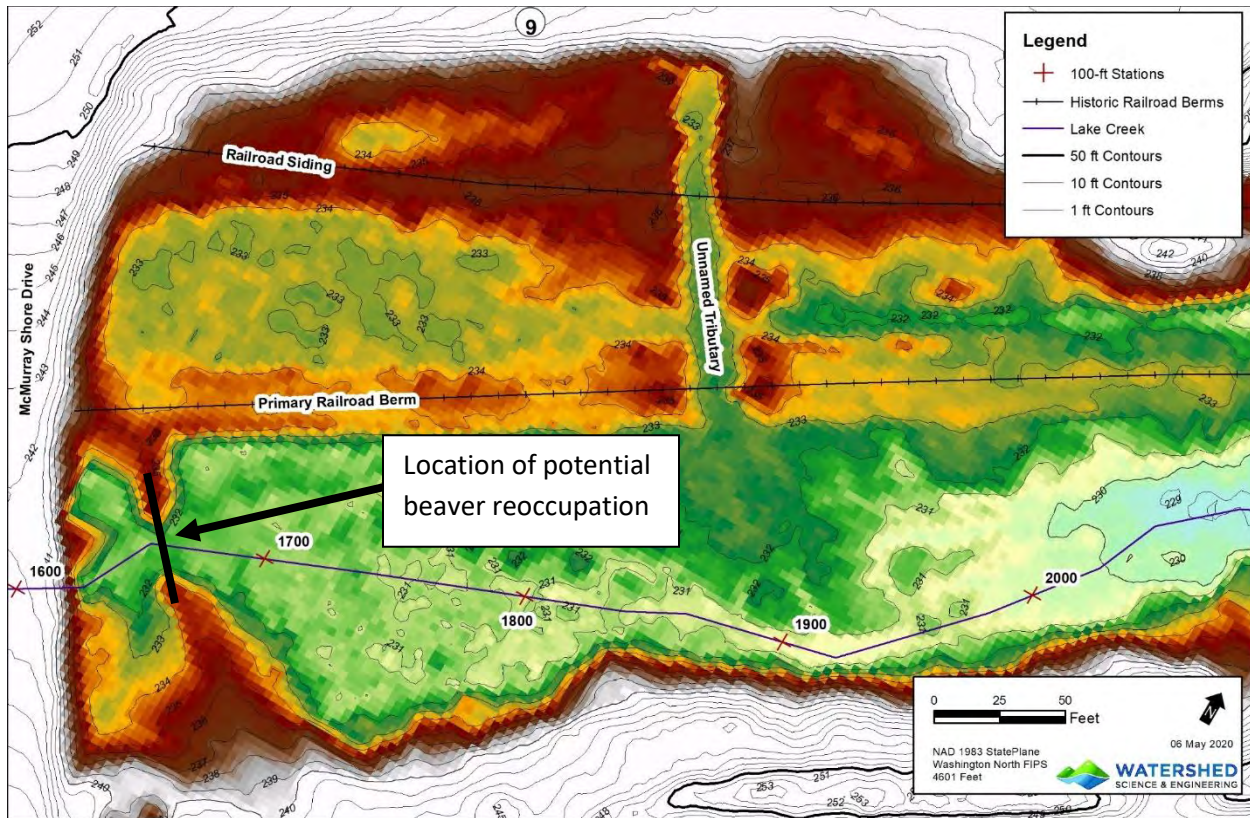
Figure 5. Lower Reach Topography near unnamed tributary to Lake Creek.

In addition to the three improvement alternatives above, WSE also analyzed what would happen if beavers reoccupy the outlet channel. As WSE observed during the February and March 2020 site visits, beavers are not actively damming the lake outlet channel, likely because the unnamed tributary sediment delta is causing water to pond upstream. This probably has reduced flow velocities enough that beavers are not attracted to the outlet channel. Higher flow velocities that would occur through implementation of improvements could attract beavers back to the outlet channel. To demonstrate the impact of beaver reoccupation, WSE used the hydraulic model to analyze the effects of beavers constructing a new dam just downstream of the McMurray Shore Drive culverts (Figure 5). According to neighbors, beavers have frequently built and maintained dams at this location in the past.

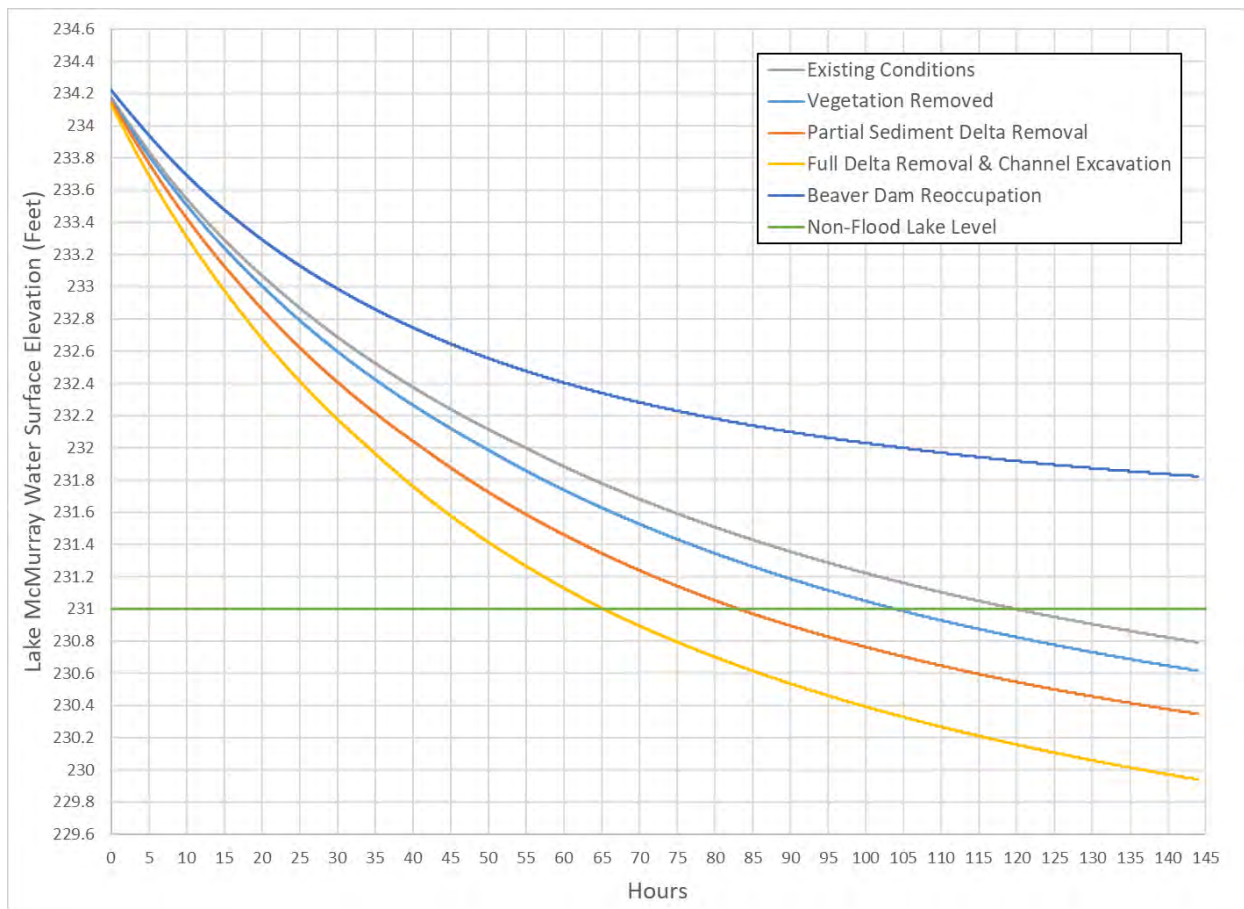
Figure 10. Lake Drainage Time for Each Hydraulic Scenario compared to Existing Conditions

Under existing conditions, the model predicts that it would take 119 hours, or just less than 5 full days for the lake to return to elevation 231.0 ft. The vegetation removal alternative improved drainage times by 16 hours, or a little more than one-half day, the partial sediment delta removal alternative improved drainage times by 36 hours, or 1.5 days, and the full delta removal and channel excavation alternative improved drainage times by 54 hours, or 2.25 days. The beaver dam reoccupation scenario demonstrated the potential negative effect if beavers reoccupy the outlet channel. In the beaver dam scenario, the lake took greater than 144 hours, or 6 days, to drain from the 2009 high lake elevation to a non-flood level. The reality, however, is that the lake would likely only drain to the elevation of the top of the beaver dam; therefore, the lake could remain at flood stage for many weeks or months.

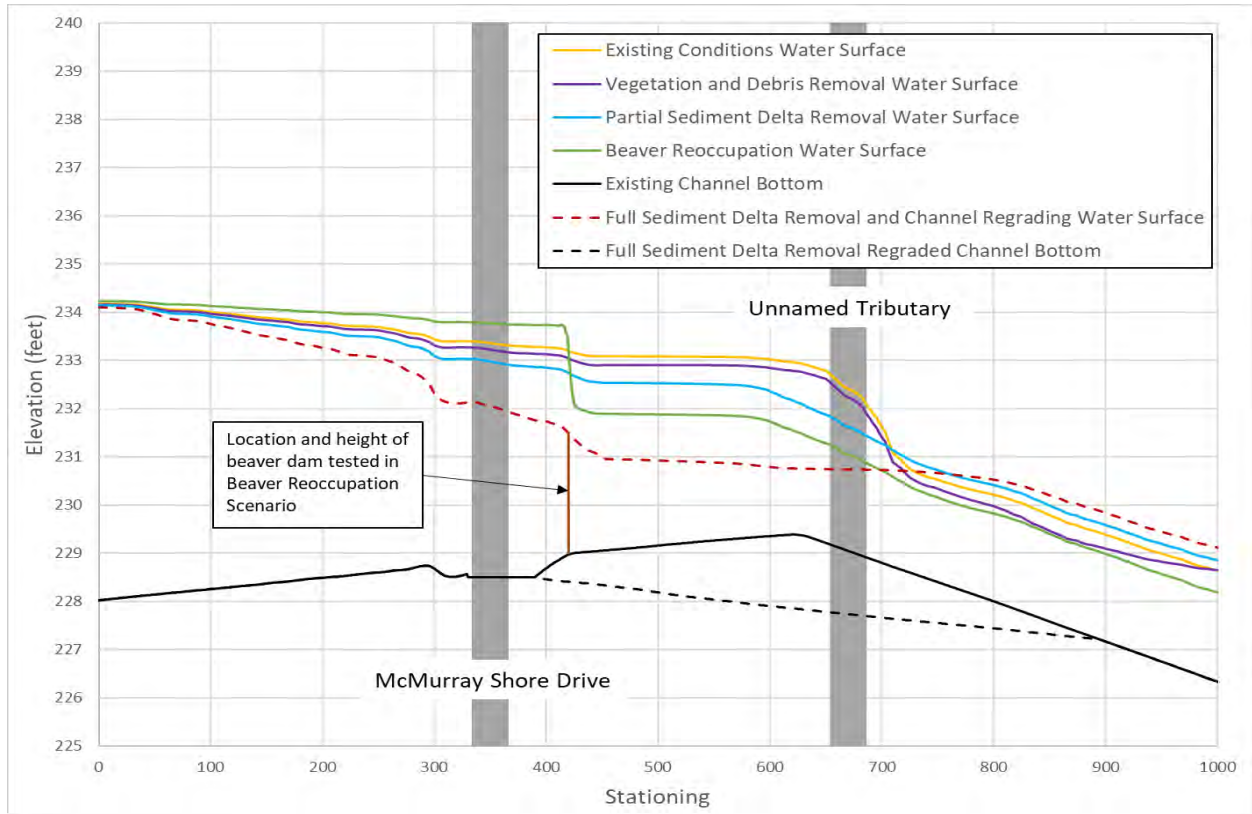
Figure 11. Water surface elevation profiles along the lake outlet channel at beginning of model simulation

Figure 11 compares the water surface profiles for each modeled scenario at the beginning of the model simulation when the lake is at the flood stage of 234.3 feet. The figure reveals that the beaver dam scenario results in the flattest water surface slope between the lake and the example dam location.

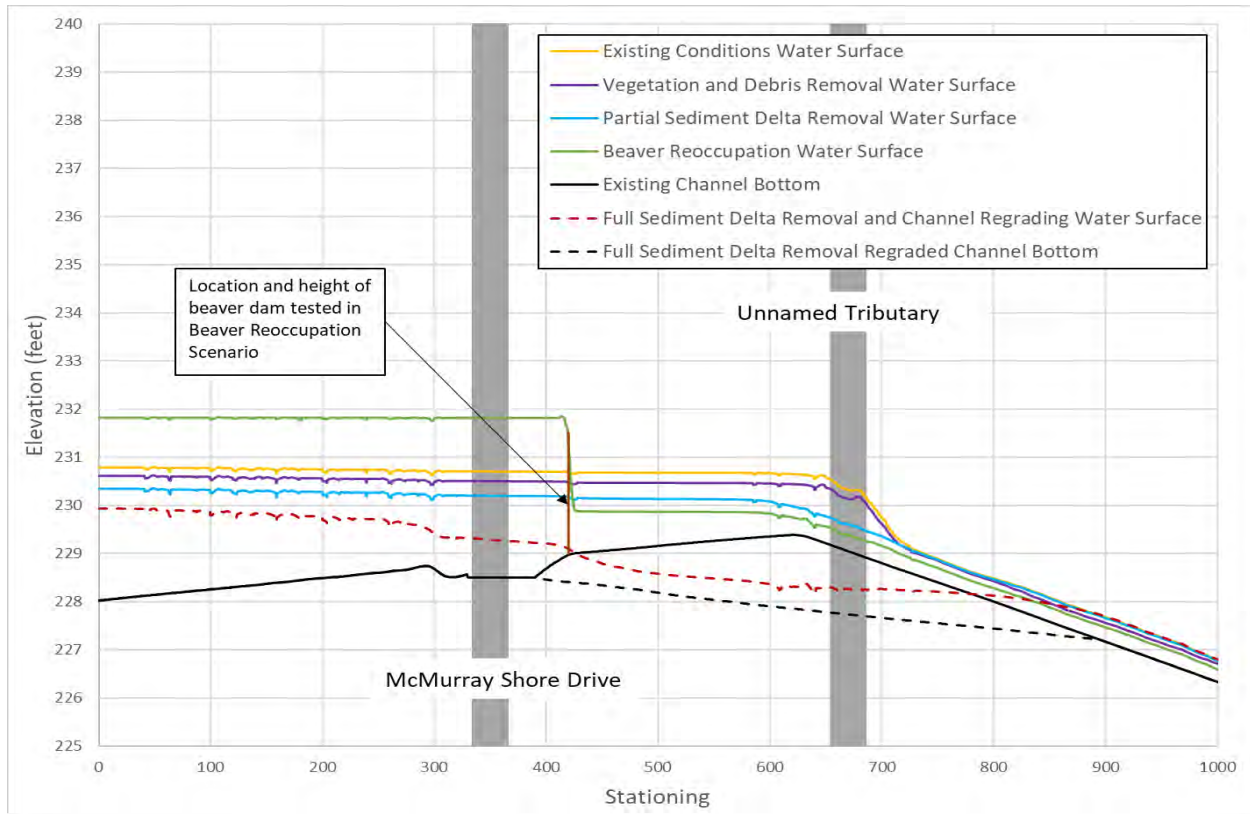
Figure 12. Water surface elevation profiles at end of model simulation (144 hours after beginning)

Figure 12 compares the water surface profiles for each modeled scenario at the end of the model simulation (at hour 144). Figure 12 shows that either leaving the sediment delta in place, partially or fully removing it impacts the time it takes for the lake to drain; however, the level eventually drains to non-flood levels for all three conditions. The simulated beaver dam scenario reveals and illustrates what we believe is the greatest concern, for theoretically the lake will only drain to the elevation of the top of the dam and will not return to elevation 231.0 feet, unless a portion of the dam is removed.
