## Stormwater Facility Background and Inspection Report

Location: 44510 Concrete Sauk Valley Rd., Concrete, WA. 98237  
Parcel number: P70969  
Owner: Skagit County  
Inspection date: 6/13/18  
Report Update: 9/20/22

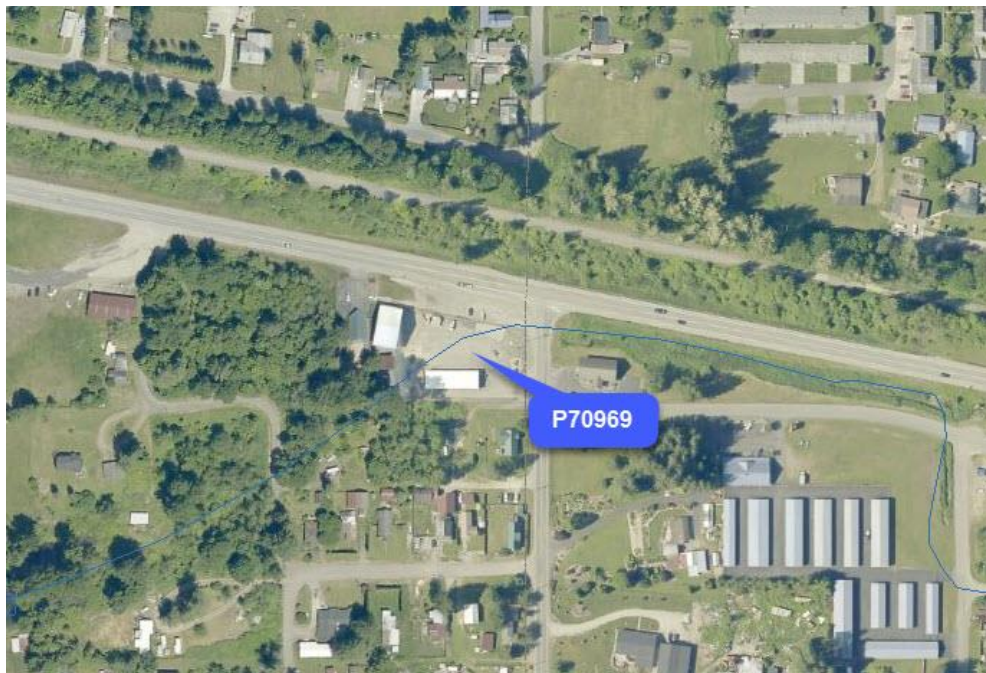
**Figure 1.** East County Road Shop in Concrete, WA. The blue line represents Lorenzan Creek as shown on Skagit County's geoSkagit 3.0 *Unnamed Rivers, Creeks and Streams* hydrology layer. It is worth noting that the stream layer is shifted slightly east of actual location.
