Re: Our Clients: Mark and Colleen Leveck  
**Appeal of Administrative Order to Abate Violation**  
**Case Number:** CODE-2025-0169  
**Property:** 33711 South Shore Drive, Mount Vernon, WA 98274

PROJECT DESCRIPTION:  
BOAT HOUSE REPAIR  
33711 S SHORE DR

**Wetland & Fish & Wildlife Habitat Site Assessment**  
**33711 South Shore Drive, Lake Cavanaugh, WA**  
**Parcel No. P66599, P66600, & P66601**

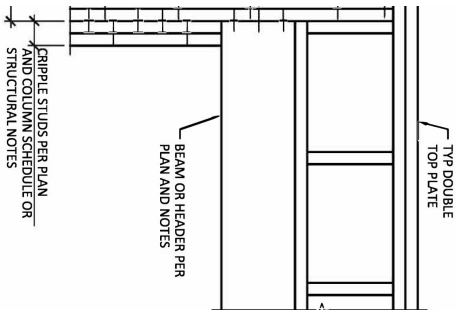
TYPICAL HEADER DETAIL

UNLESS NOTED OTHERWISE, HEADERS AT ALL EXTERIOR WALLS SHALL BE 4x6 HF#2 WHERE MAXIMUM SPAN= 4'-0". HEADERS TO BE SUPPORTED BY MINIMUM OF (1) CRIPPLE STUD & (1) FULL HEIGHT STUD. UNO

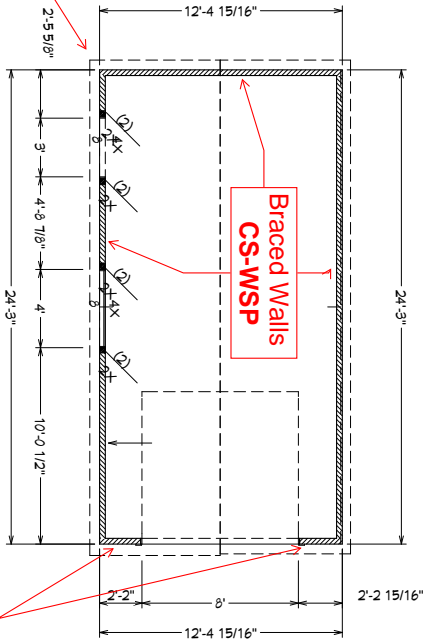
MAIN FLOOR FRAMING DOOR AND WINDOW

Wall to remain as existing. Only replacing garage door

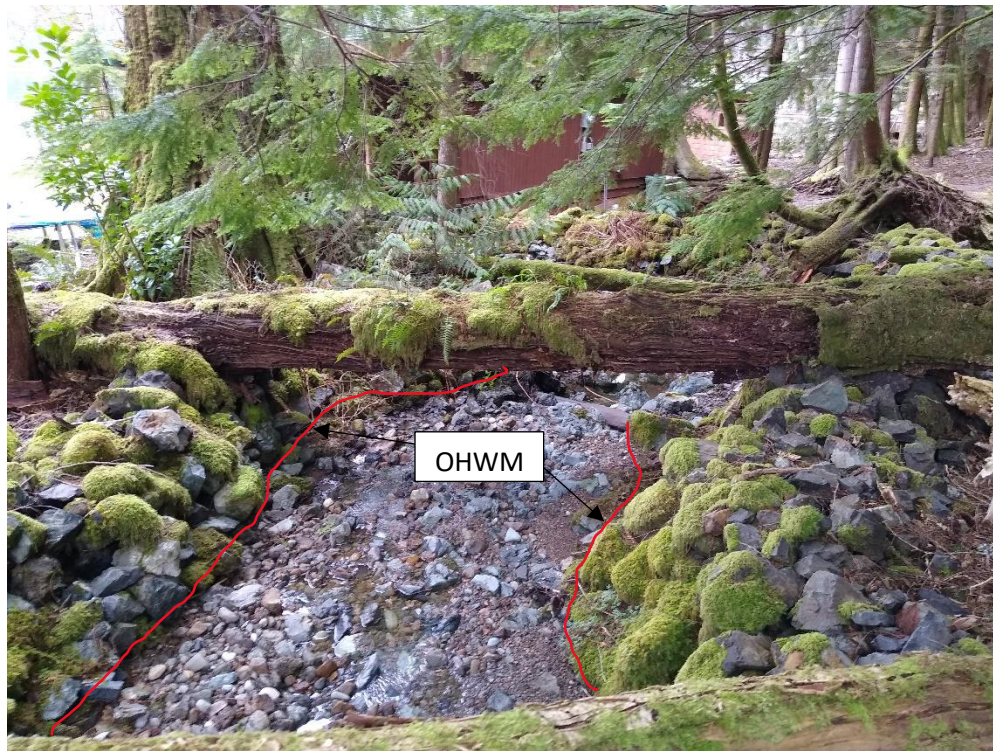
Photo 3: View of the type F stream from the bridge and OHWM.

As indicated in Photo 3 above, the location of the OHWM for the type F stream was again confirmed in the field and flagged. As previously mentioned, this is an alluvial depositional stream with low stream flow. Therefore, minimal stream incision was observed on the subject parcel. In general, sediment deposits, alluvial scour lines and upland vegetation along the man-made rockery bank identify the OHWM.

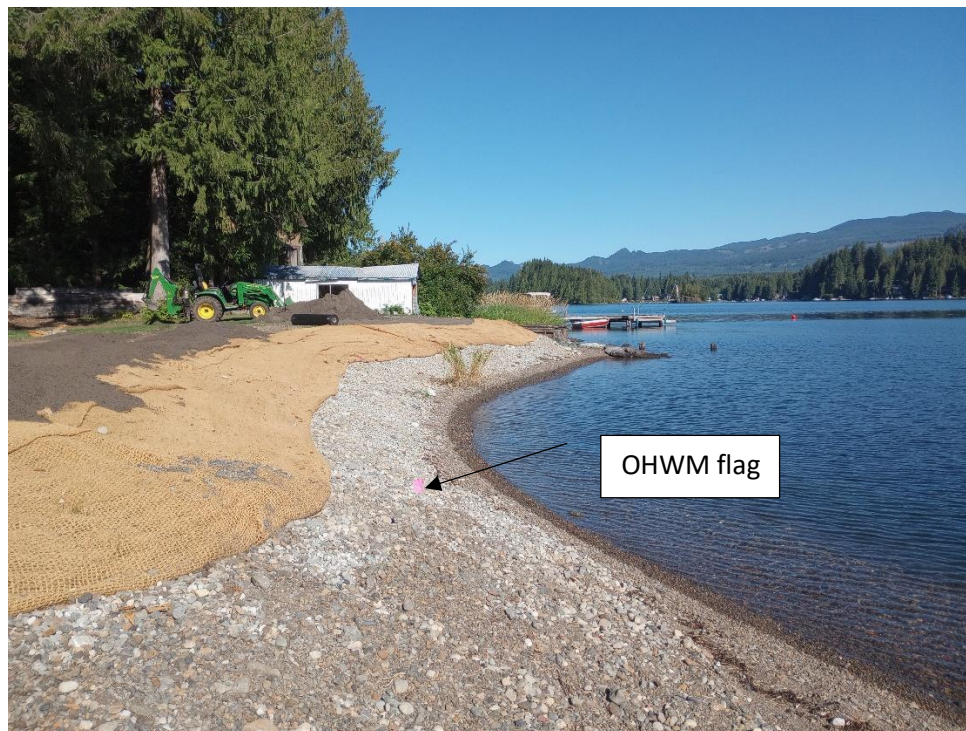
Photo 4: Bulkhead removal, shoreline restoration and OHWM identification.

The ordinary high water mark (OHWM) was previously established by Edison Engineering for the shoreline of the subject site. CGS evaluated the site by examining drift lines, the geomorphic profile of the shoreline and the identification of a prevalence of upland vegetation. During our February site visit, we determined that the OHWM of Lake Cavanaugh established by Edison Engineering was accurate. It also came to our attention that a Washington Department of Fish and Wildlife (WDFW) enforcement action was in effect to remove the bulkhead, northwest of the existing cabin, and restore the shoreline to its previous function.

and geomorphic characteristics were absent. The OHWM in this area was determined based on topographic elevations of non-disturbed OHWM locations northwest and southeast of restoration area. As indicated in Photo 4 above, OHWM locations were flagged in the field.

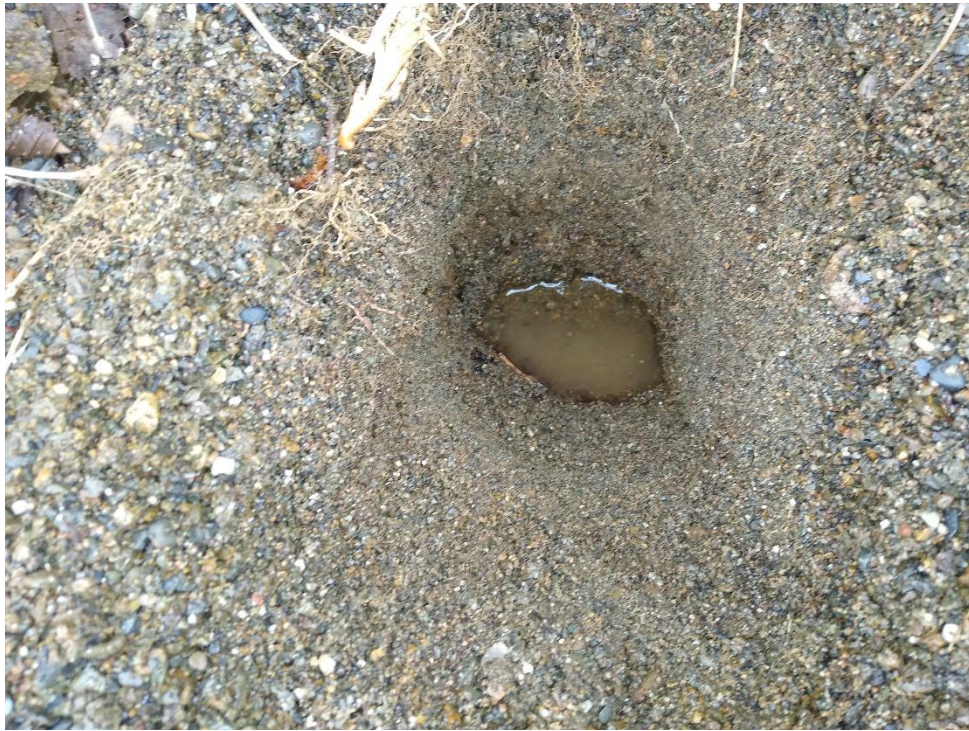
Photo 2: View of hydrologic conditions near sample point SP-2, greater than 12 inches deep.

Sample point holes were left open during the sampling process to allow groundwater levels to stabilize or saturation to become evident. Primary hydrologic indicators were observed in sample point SP-1. However, sample points SP-2 and SP-3 did not indicate primary or secondary hydrologic indicators. Although sample point SP-1 does meet the criteria for wetland hydrology, it is our professional opinion that sample points SP-2 and SP-3 do not meet the criteria for wetland hydrology.
