Survey in the NW1/4 of the SE1/4 (Gov't Lot 7) of Section 1, Twp. 34 N., Rng. 4 E., W.M.

Survey for Nathan Sloniker

Skagit Surveyors & Engineers

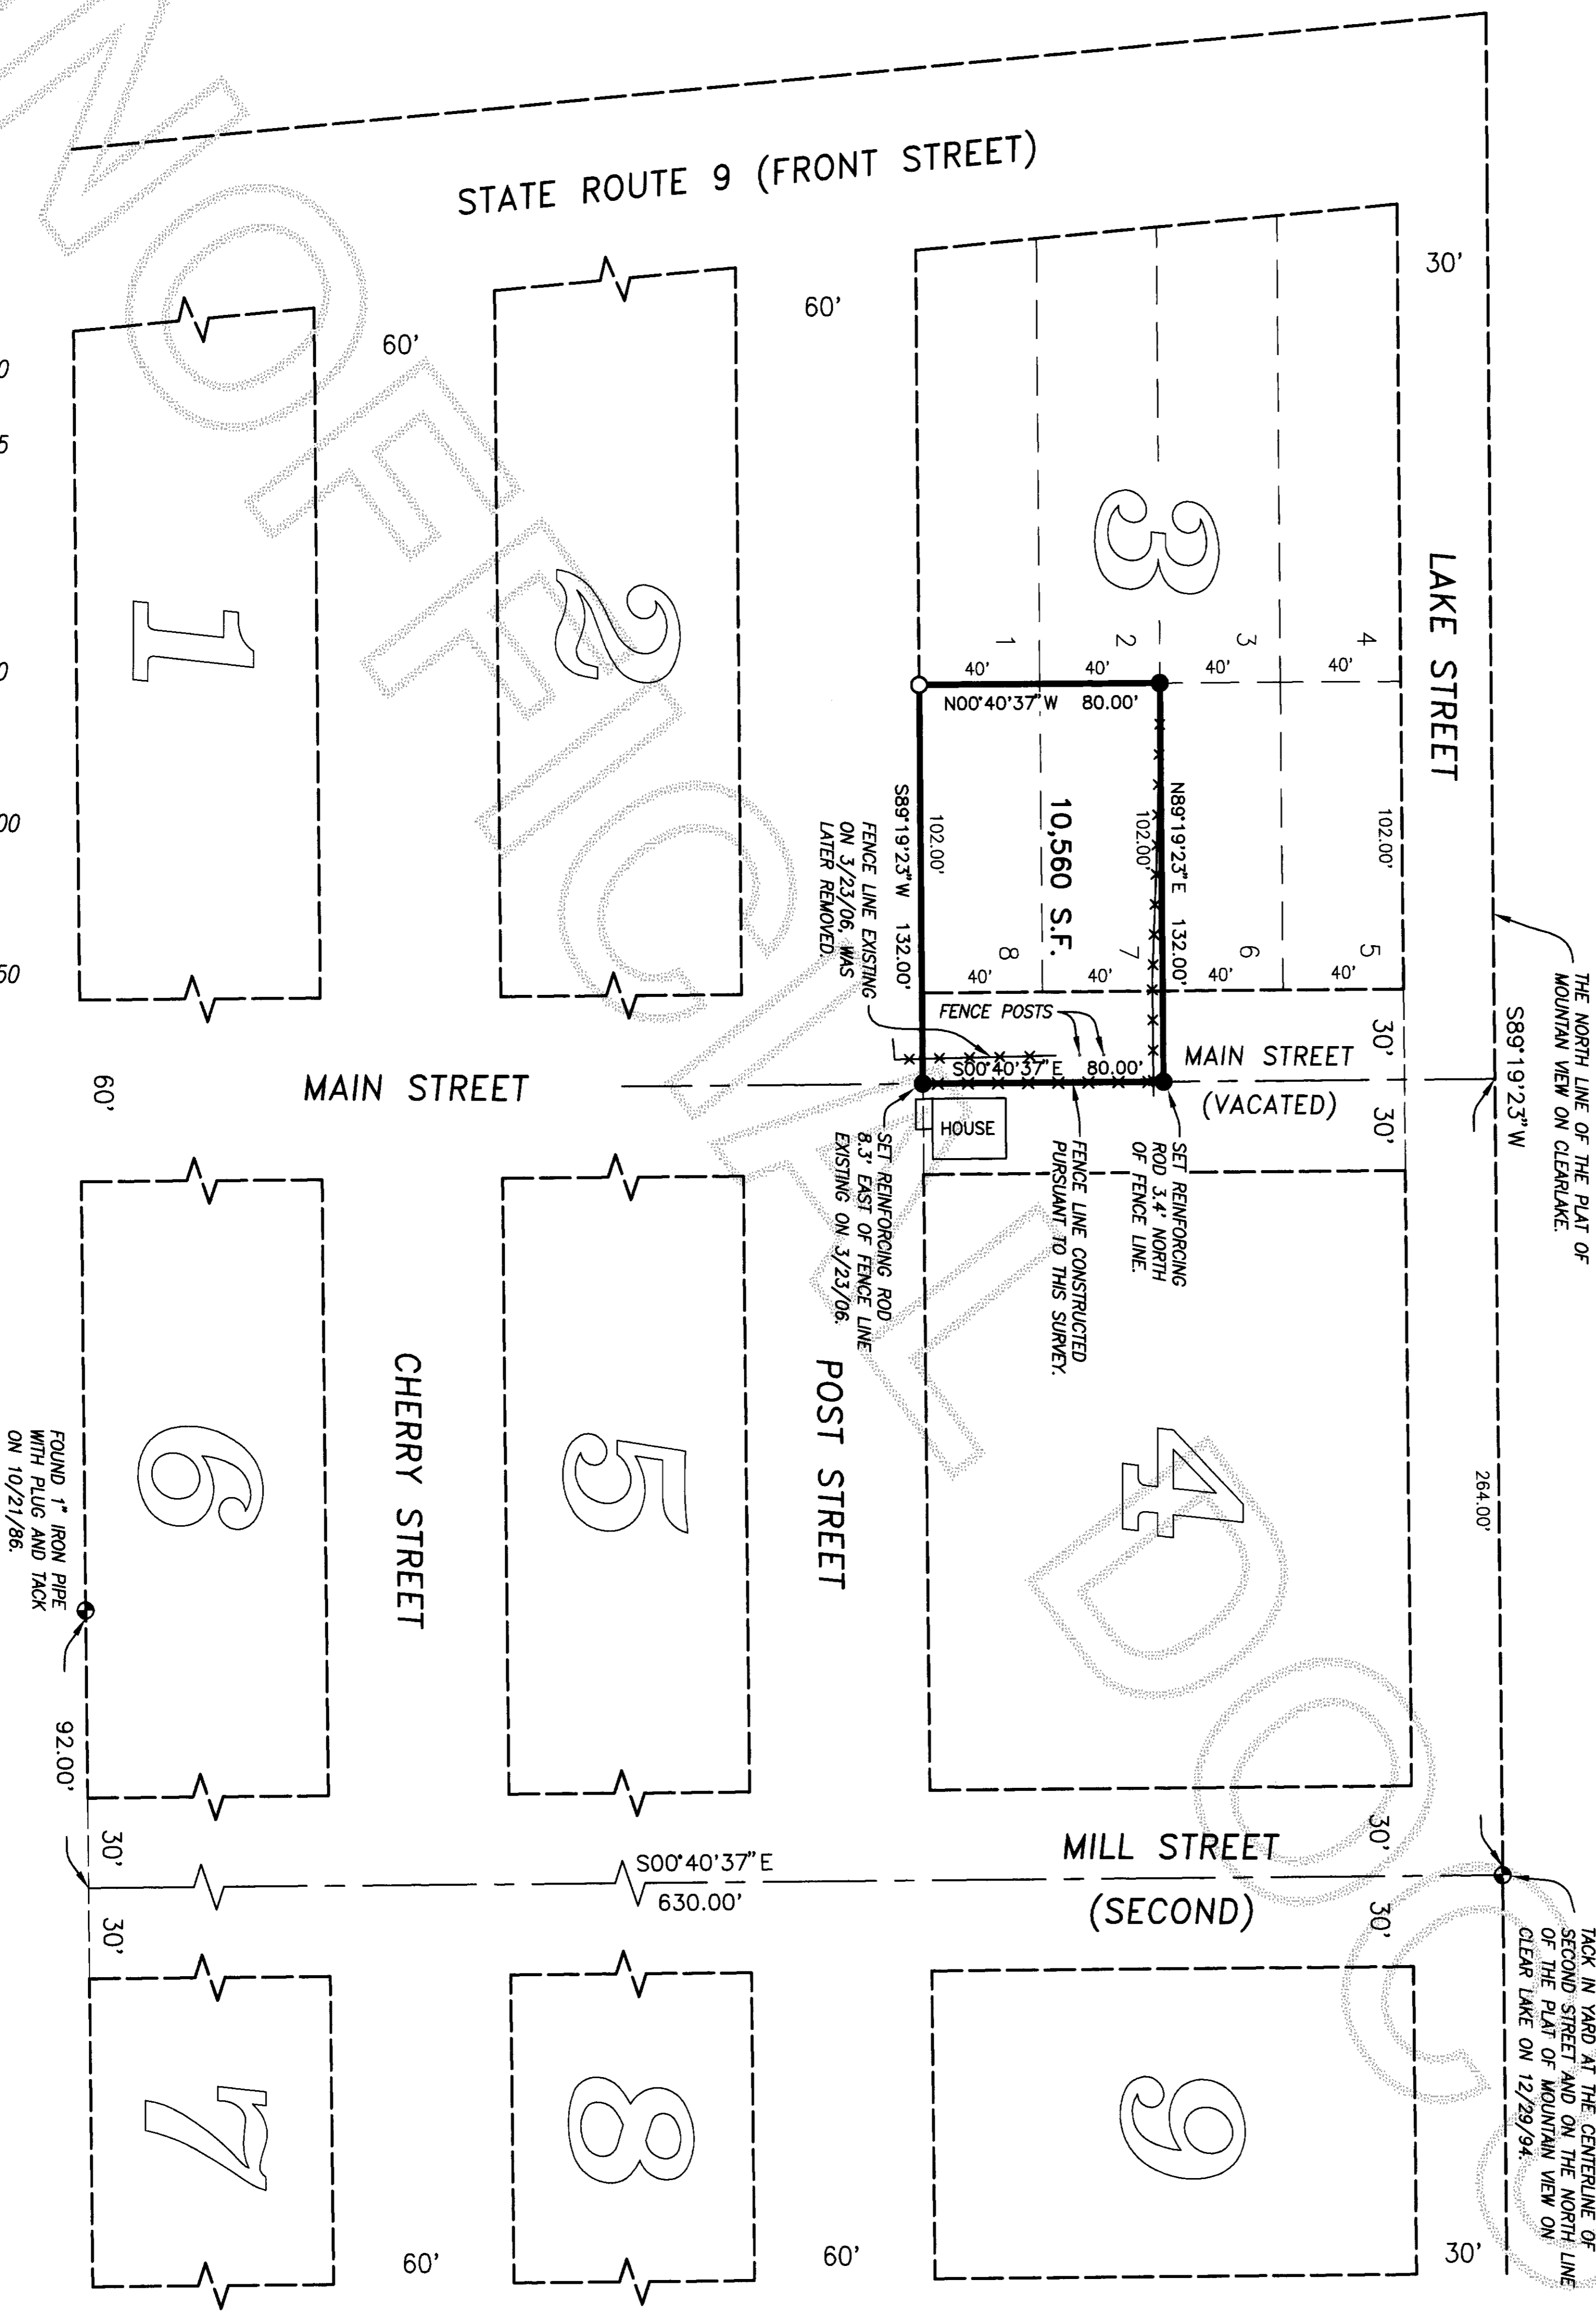
Lots 7 and 8 of Block 3, "Plat of Mountain View On Clear Lake" recorded in Volume 2 of Plats at Page 65, records of Skagit County, Washington, TOGETHER WITH the west 30 feet of vacated Main Street

1. Basis-of-bearings - Assumed S00°40'37"E on the centerline of the Second Street per survey recorded in Volume 16 of Surveys at page 190.
2. For additional information see survey recorded in Volume 16 of Surveys at page 190 and survey filed in A.F.#200410250187.
3. This survey was accomplished by field traverse using: 3 second or better digital electronic total station, and meets or exceeds the standards contained in WAC 332-130-090.
