**Figure 1.**  
**Lorenzan Creek**  
**Hydraulic Model Results**  
**Existing Conditions**

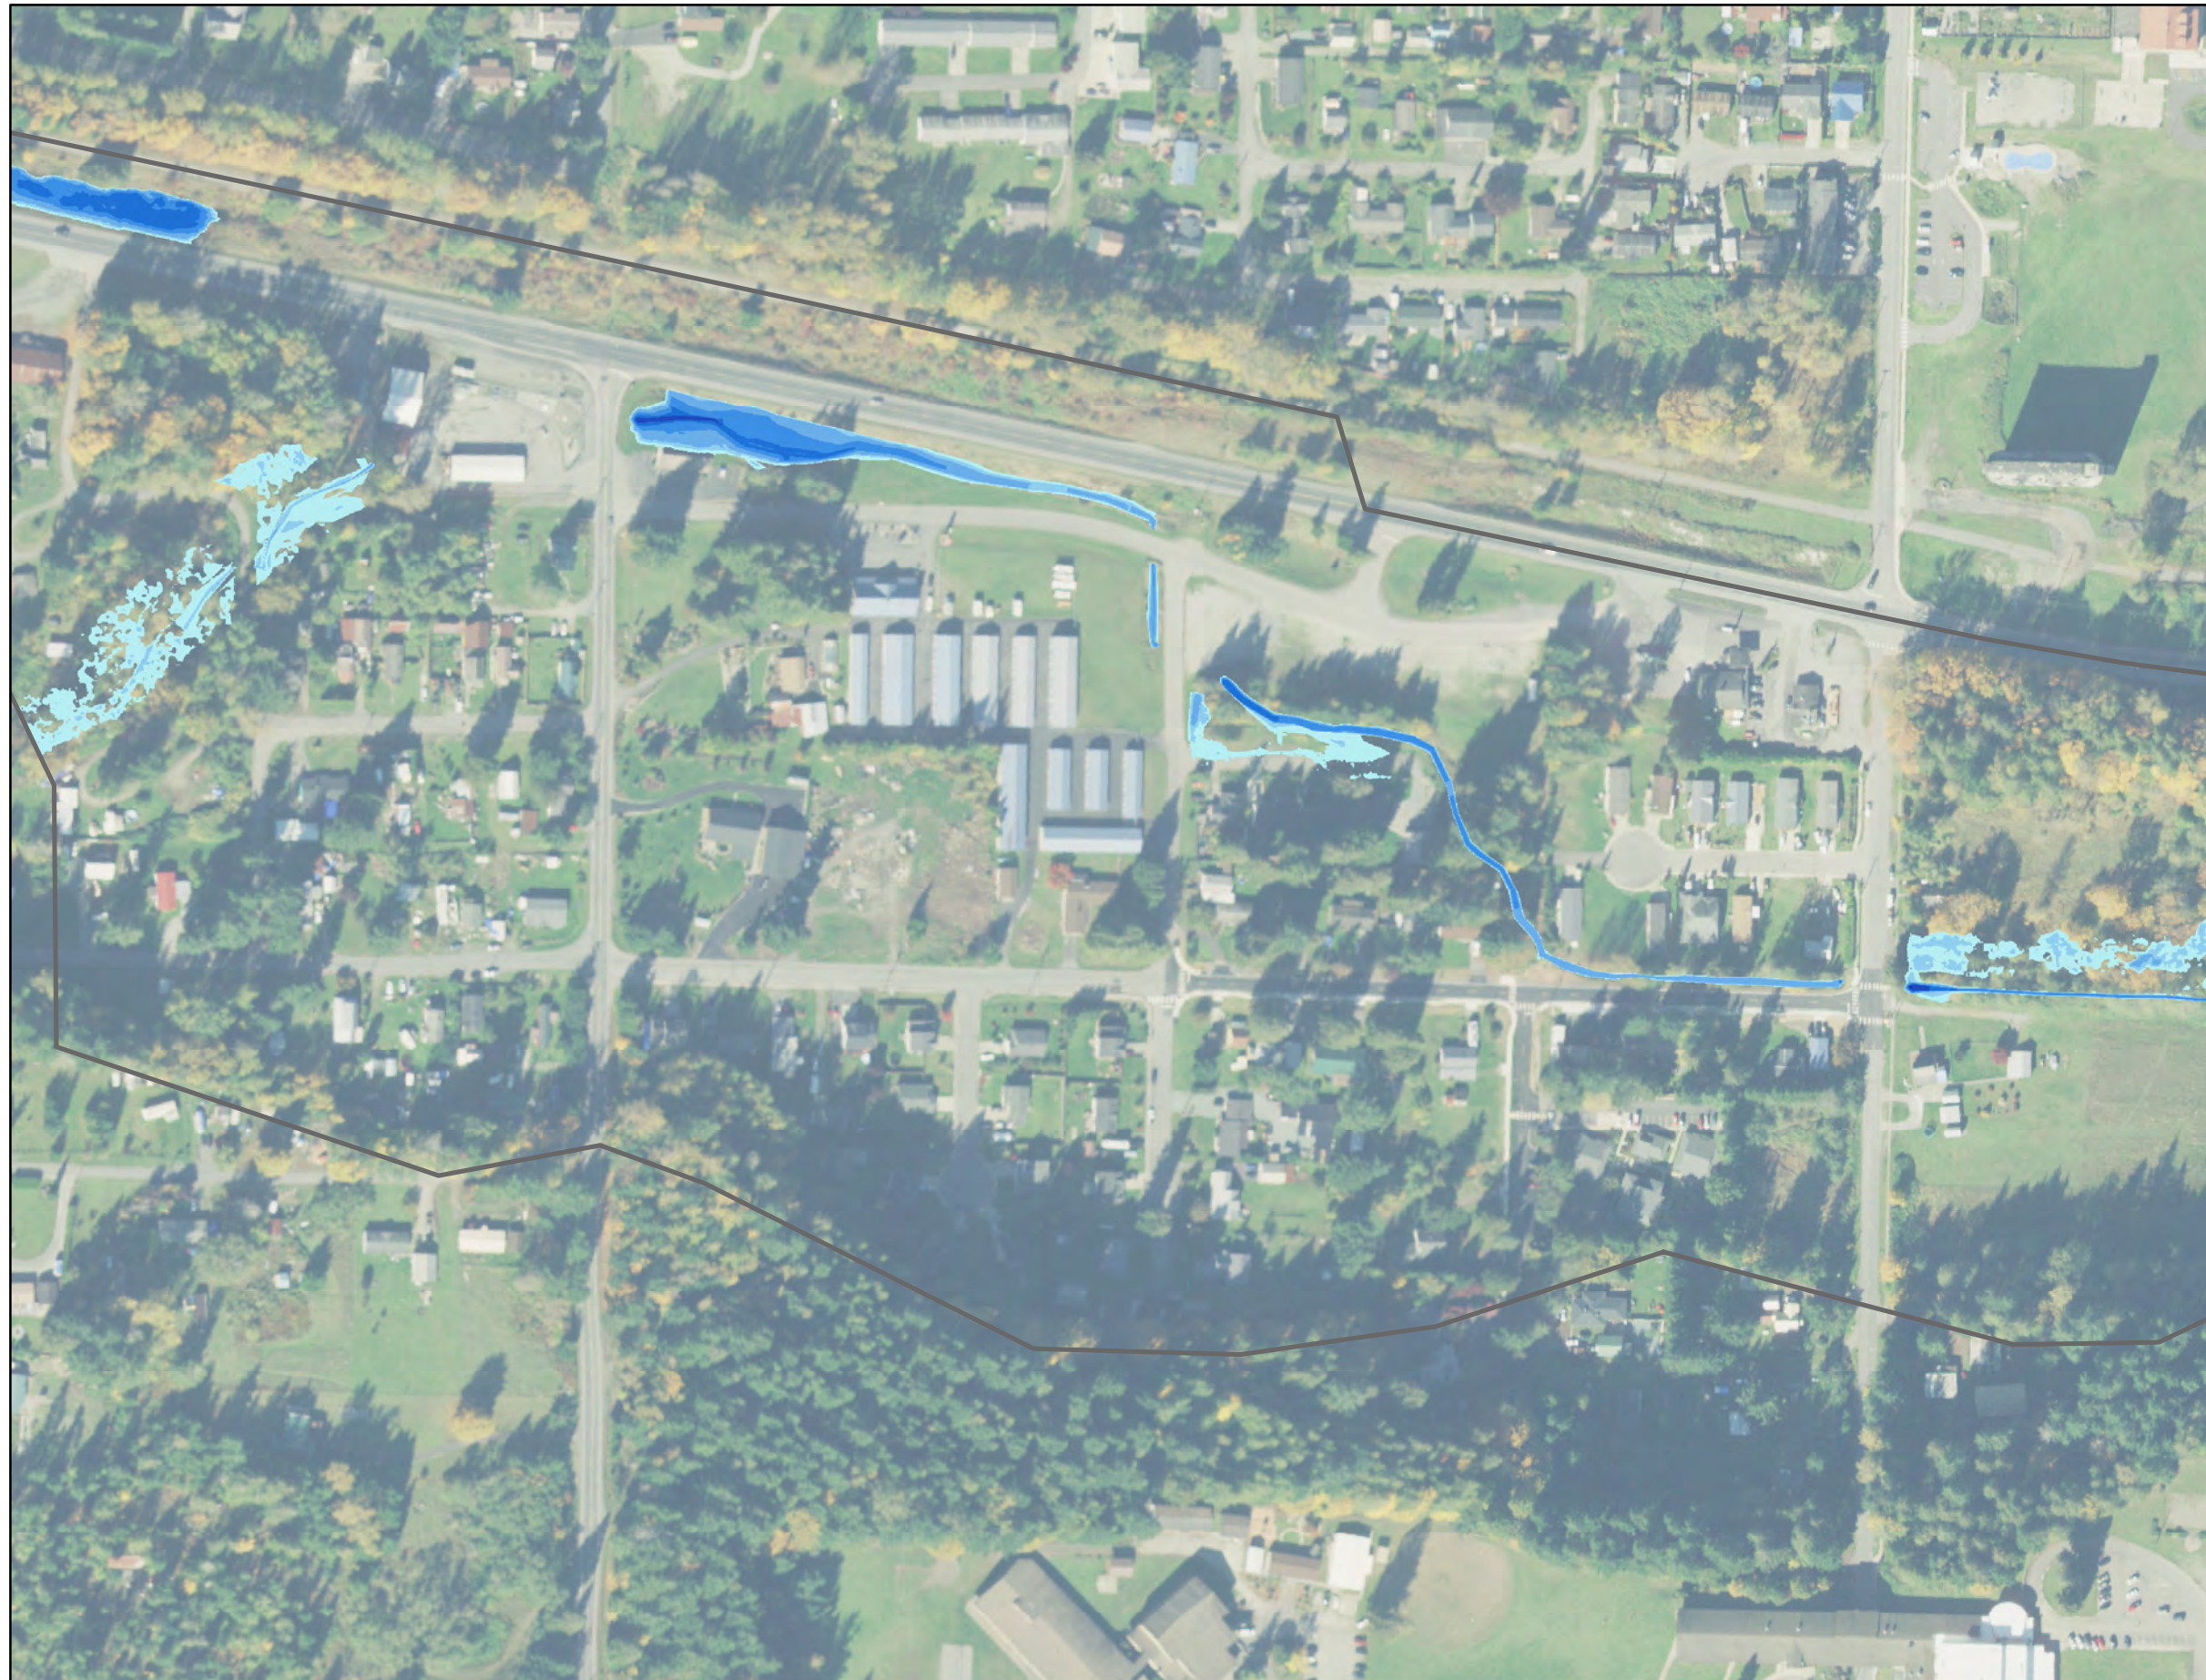
**2-yr Flood Depth**  
 (feet)

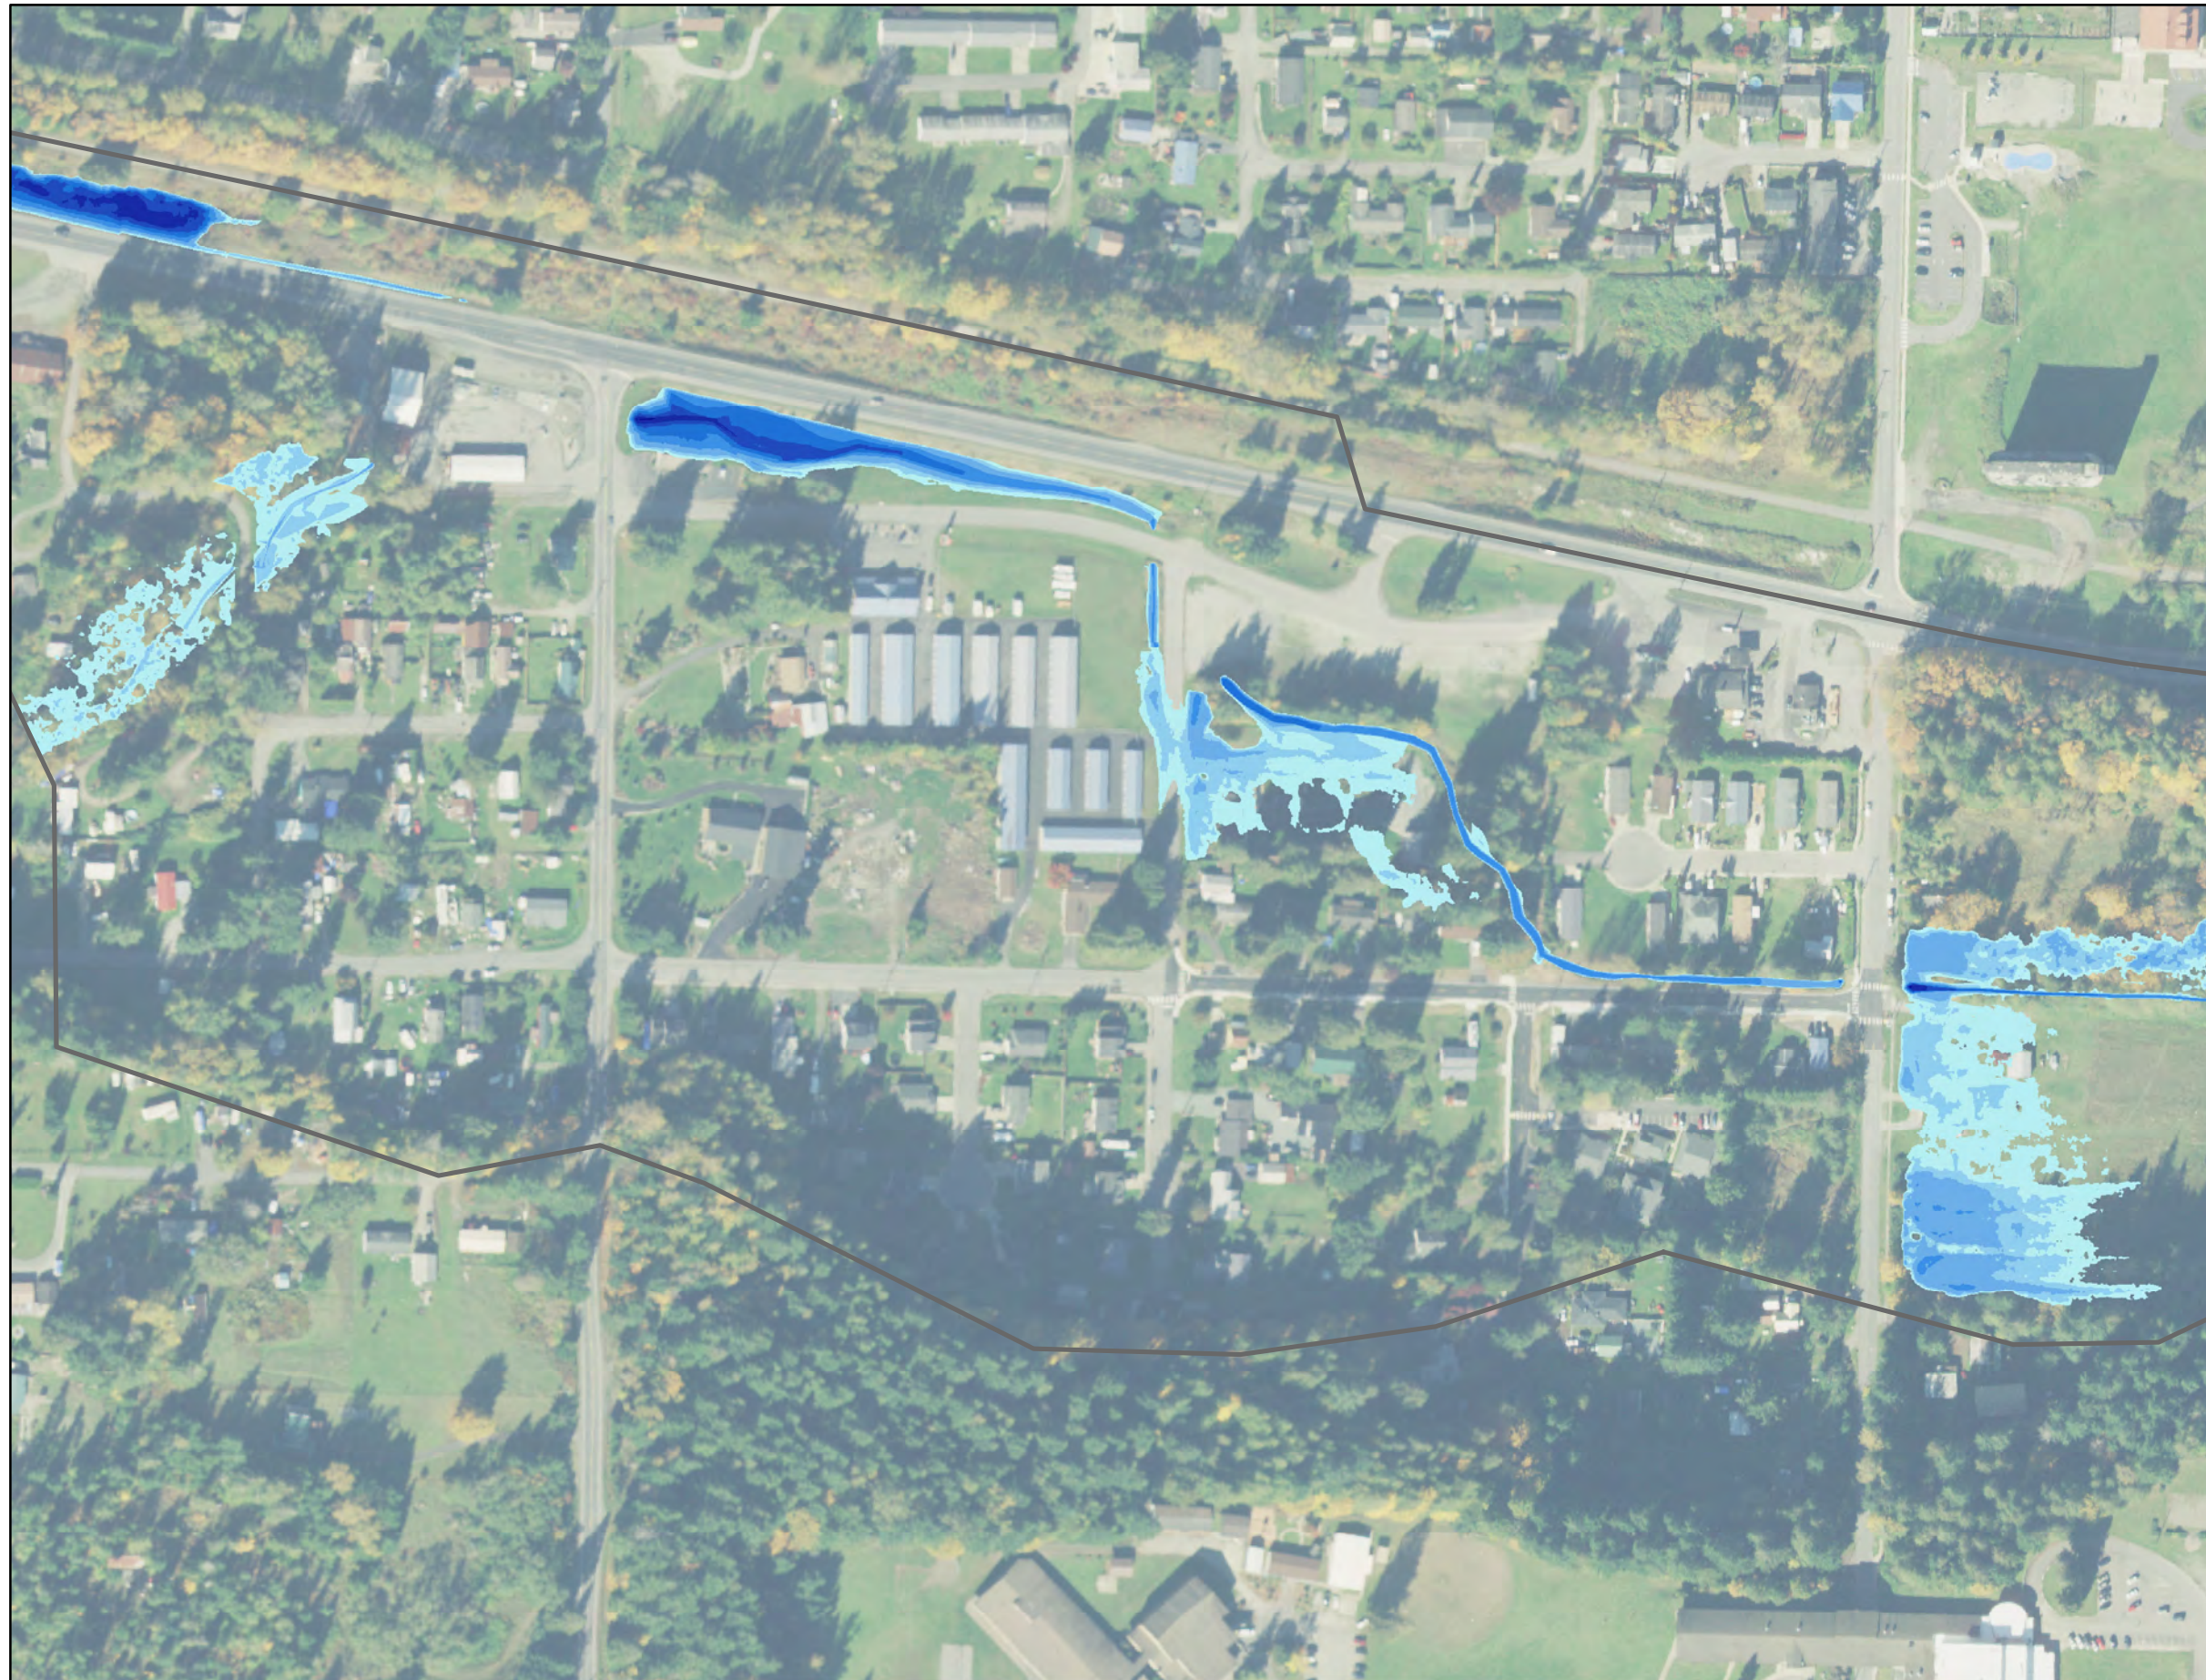
**Figure 2.**  
**Lorenzan Creek**  
**Hydraulic Model Results**  
**Existing Conditions**

**10-yr Flood Depth**  
 (feet)

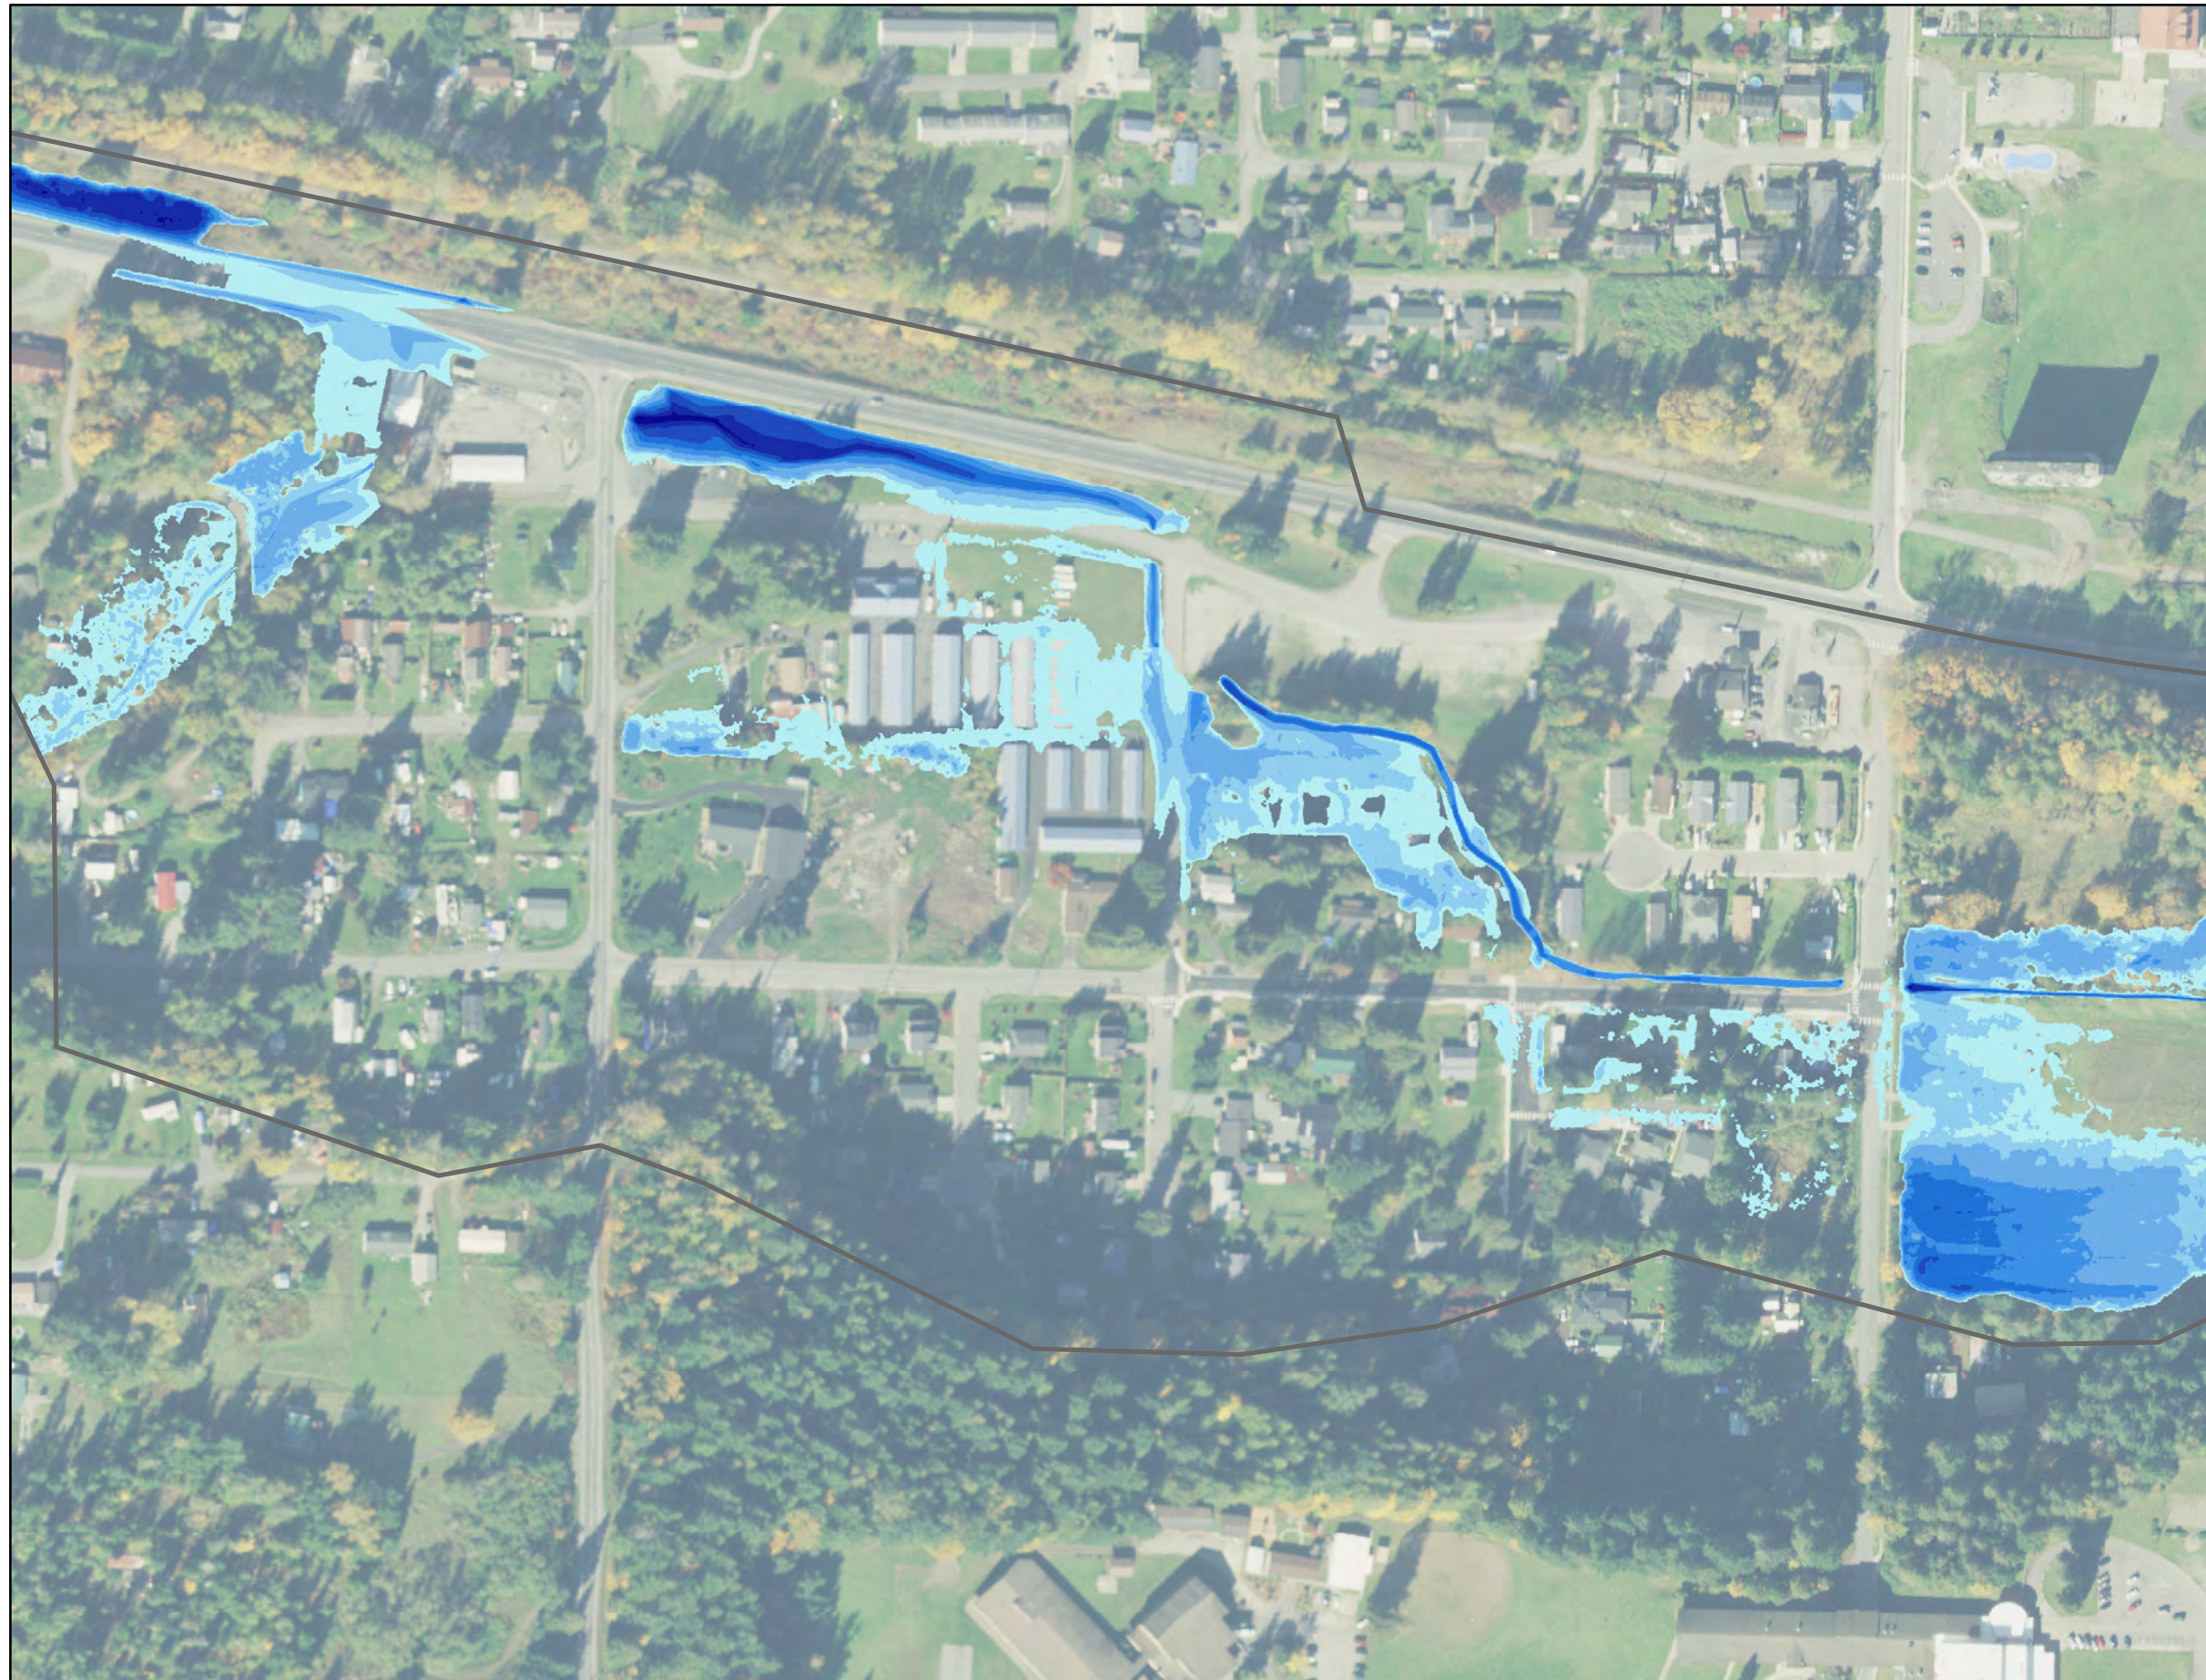
**Figure 3.**  
**Lorenzan Creek**  
**Hydraulic Model Results**  
**Existing Conditions**

**100-yr Flood Depth**  
 (feet)
