Table 1  
ACM Sample Analytical Results  
700 South 2nd Street, Mt. Vernon, WA  
Skagit County Facilities

SKAGIT COUNTY  
 ADMINISTRATION BUILDING  
 PROSECUTOR OFFICE T.I.  
 700 S. SECOND STREET  
 MOUNT VERNON, WA 98273

SHEET TITLE:  
 THIRD FLR. SOUTH DEMO PLAN

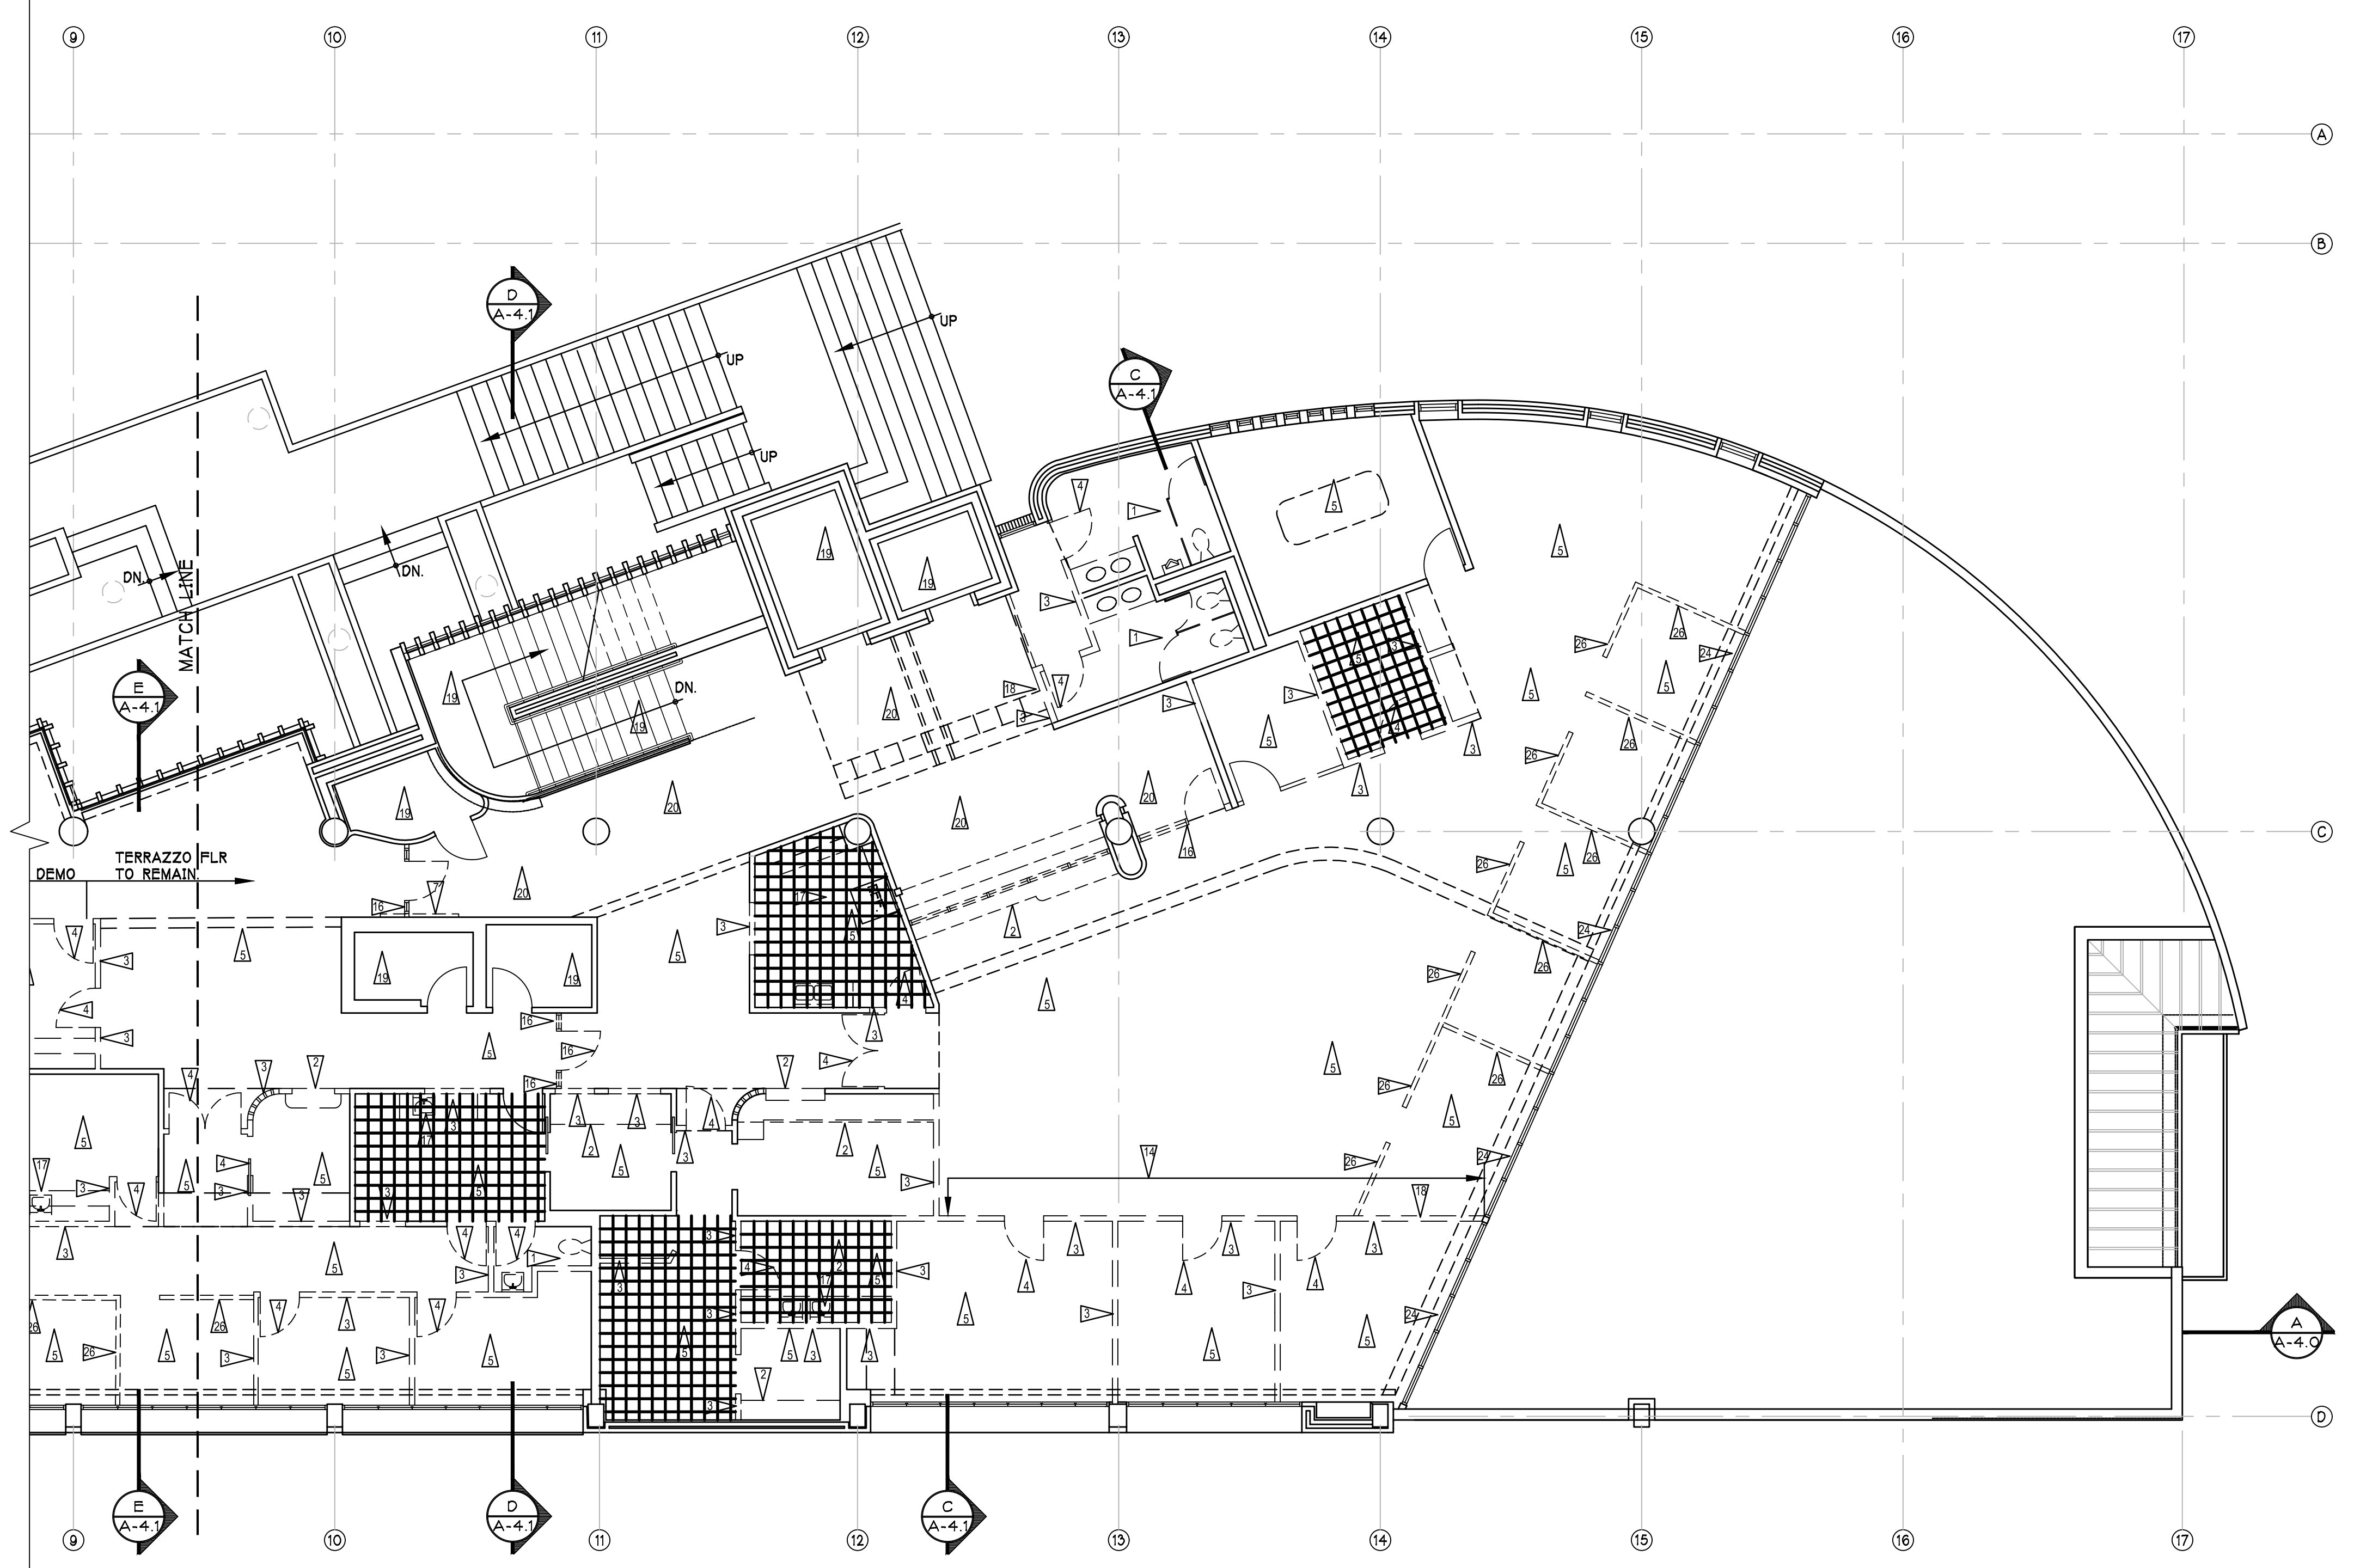
1 THIRD FLOOR PLAN-SOUTH DEMO PLAN  
 1/8"=1'-0"

- DEMOLITION FLOOR PLAN NOTES.**
- REMOVE EXIST. PLUMBING FIXTURES, COUNTERTOPS, FLOOR/WALL TILE AND PLASTIC LAMINATE TOILET PARTITIONS. SEE FINISH SCHEDULE SHEET A-2.11 FOR NEW FINISHES. FIELD VERIFY ALL LOCATIONS OF EXIST. FINISHES.

- REMOVE EXISTING CASEWORK AND COUNTERTOP. PATCH AND REPAIR EXIST. GWB AS REQUIRED. FIELD VERIFY ALL CASEWORK/COUNTERTOPS TO BE REMOVED.
  - REMOVE EXISTING NON-BEARING WALL FRAMING.

- REMOVE EXIST. WOOD DOOR, HM. FRAME & HARDWARE.
  - REMOVE EXIST. FLOOR FINISHES. REMOVE EXIST. WOOD/VINYL RUBBER BASE AS REQUIRED TO ACCOMMODATE NEW FLOOR FINISHES SEE FINISH SCHEDULE SHEET A-2.11 FOR NEW FINISHES. FIELD VERIFY ALL LOCATIONS OF EXIST. FINISHES.

- REMOVE ASBESTOS CONTAINING MATERIAL
  - REMOVE EXIST. APPROXIMATELY 54" HIGH FRAMED PARTITION WALLS. APPROXIMATELY 240 LINEAL FEET. SEE ELECTRICAL DWGS. FOR DEMO OF ELECTRICAL AND DATA/TELECOM OUTLETS
