**CXT AT SKAGIT  
FAIRGROUNDS**

# **PROJECT MANUAL**

**March 17, 2025**

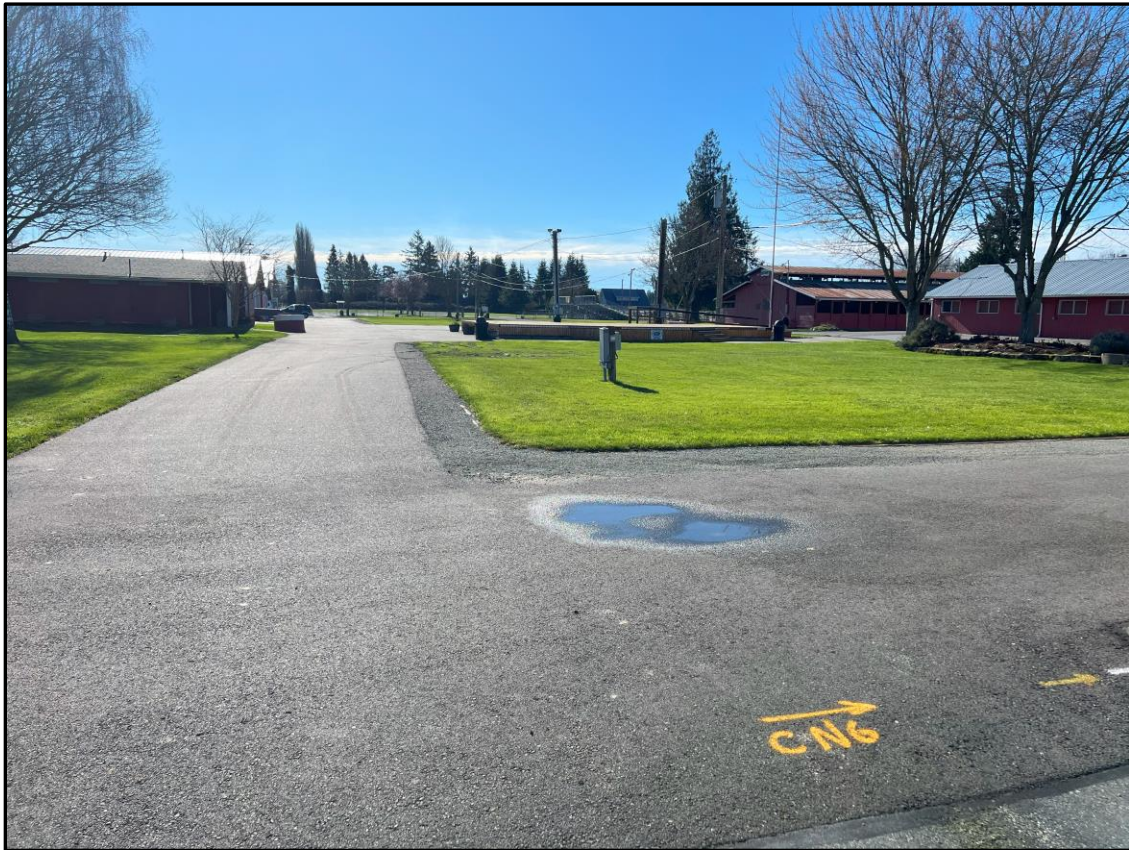
**Image 2.** Site conditions showing the relatively flat surface conditions, maintained lawn, and asphalt drive paths and walkways. The photo was taken facing south on February 16<sup>th</sup>, 2024.

The subject area is relatively flat with less than a few feet of elevation differential across the property. GeoTest observed a several existing utility alignments and easements around the parcels.

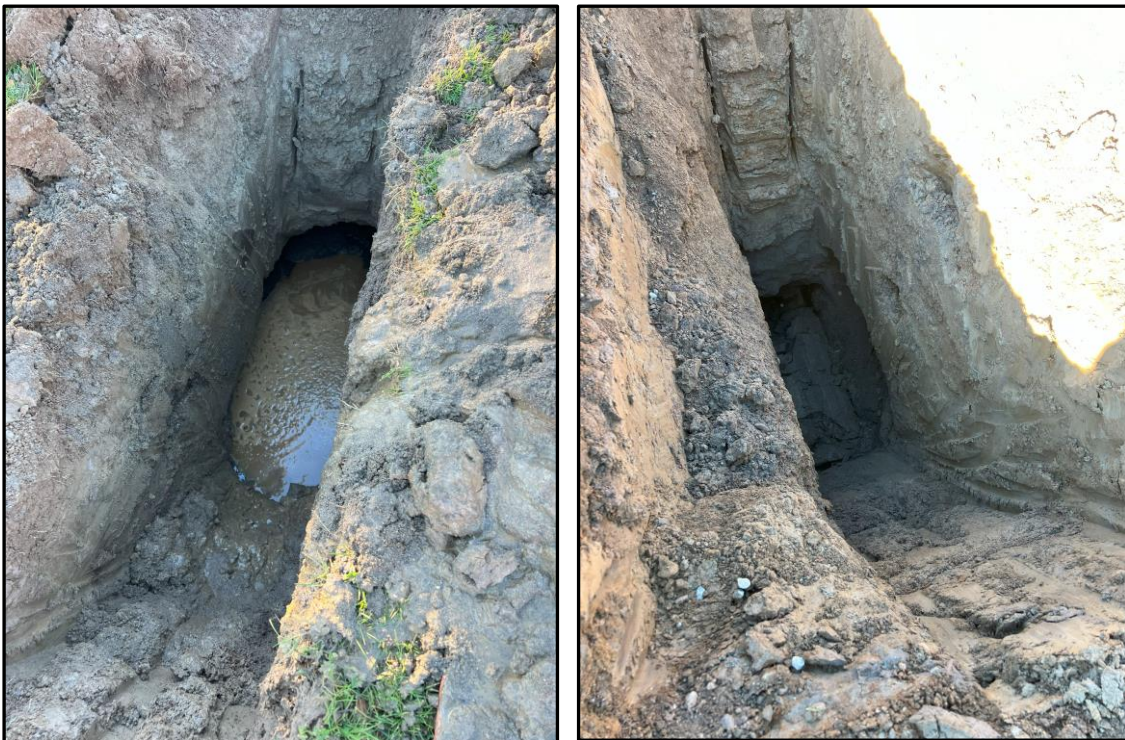
**Images 3 and 4.** TP-1 with groundwater at 4 feet BGS (left) and TP-2 (right) during explorations. Photos were taken during the site explorations on February 16<sup>th</sup>, 2024.

In TP-1, the soils encountered between 0 and 2 feet BGS were described as stiff to very stiff, brown to tan, damp to moist, slightly gravelly, slightly sandy silt with occasional organics and light orange mottling. These near surface soils were interpreted as uncontrolled fill. Below the fill soils, between 2 and 2.5 feet BGS, GeoTest interpreted the materials as Relict Topsoil and described them as stiff to very stiff, brown to black, damp to moist, sandy silt with occasional organics. The soils below the Relict Topsoil, between 2.5 and 4 feet BGS were described as very stiff, gray brown to brown, moist to wet, sandy silt with light orange mottling. These soils were interpreted as weathered Alluvial Deposits. Between 4 feet and the termination depth of 7 feet BGS, medium dense to dense, gray brown, wet, very silty sands were encountered and described as unweathered Alluvial Deposits.

In TP-2, previously placed fill materials (Road Base) were encountered at the surface to 1-foot BGS and was described as dense to very dense, gray, damp, sandy gravels. Below the Road Base, the same weathered Alluvial Deposits were described in TP-1 and were encountered between 1 and 5 feet BGS. GeoTest encountered medium dense, dark gray brown, damp, very silty sands below the weathered material between 5 and 8 feet BGS and interpreted the soils as unweathered Alluvial Deposits.

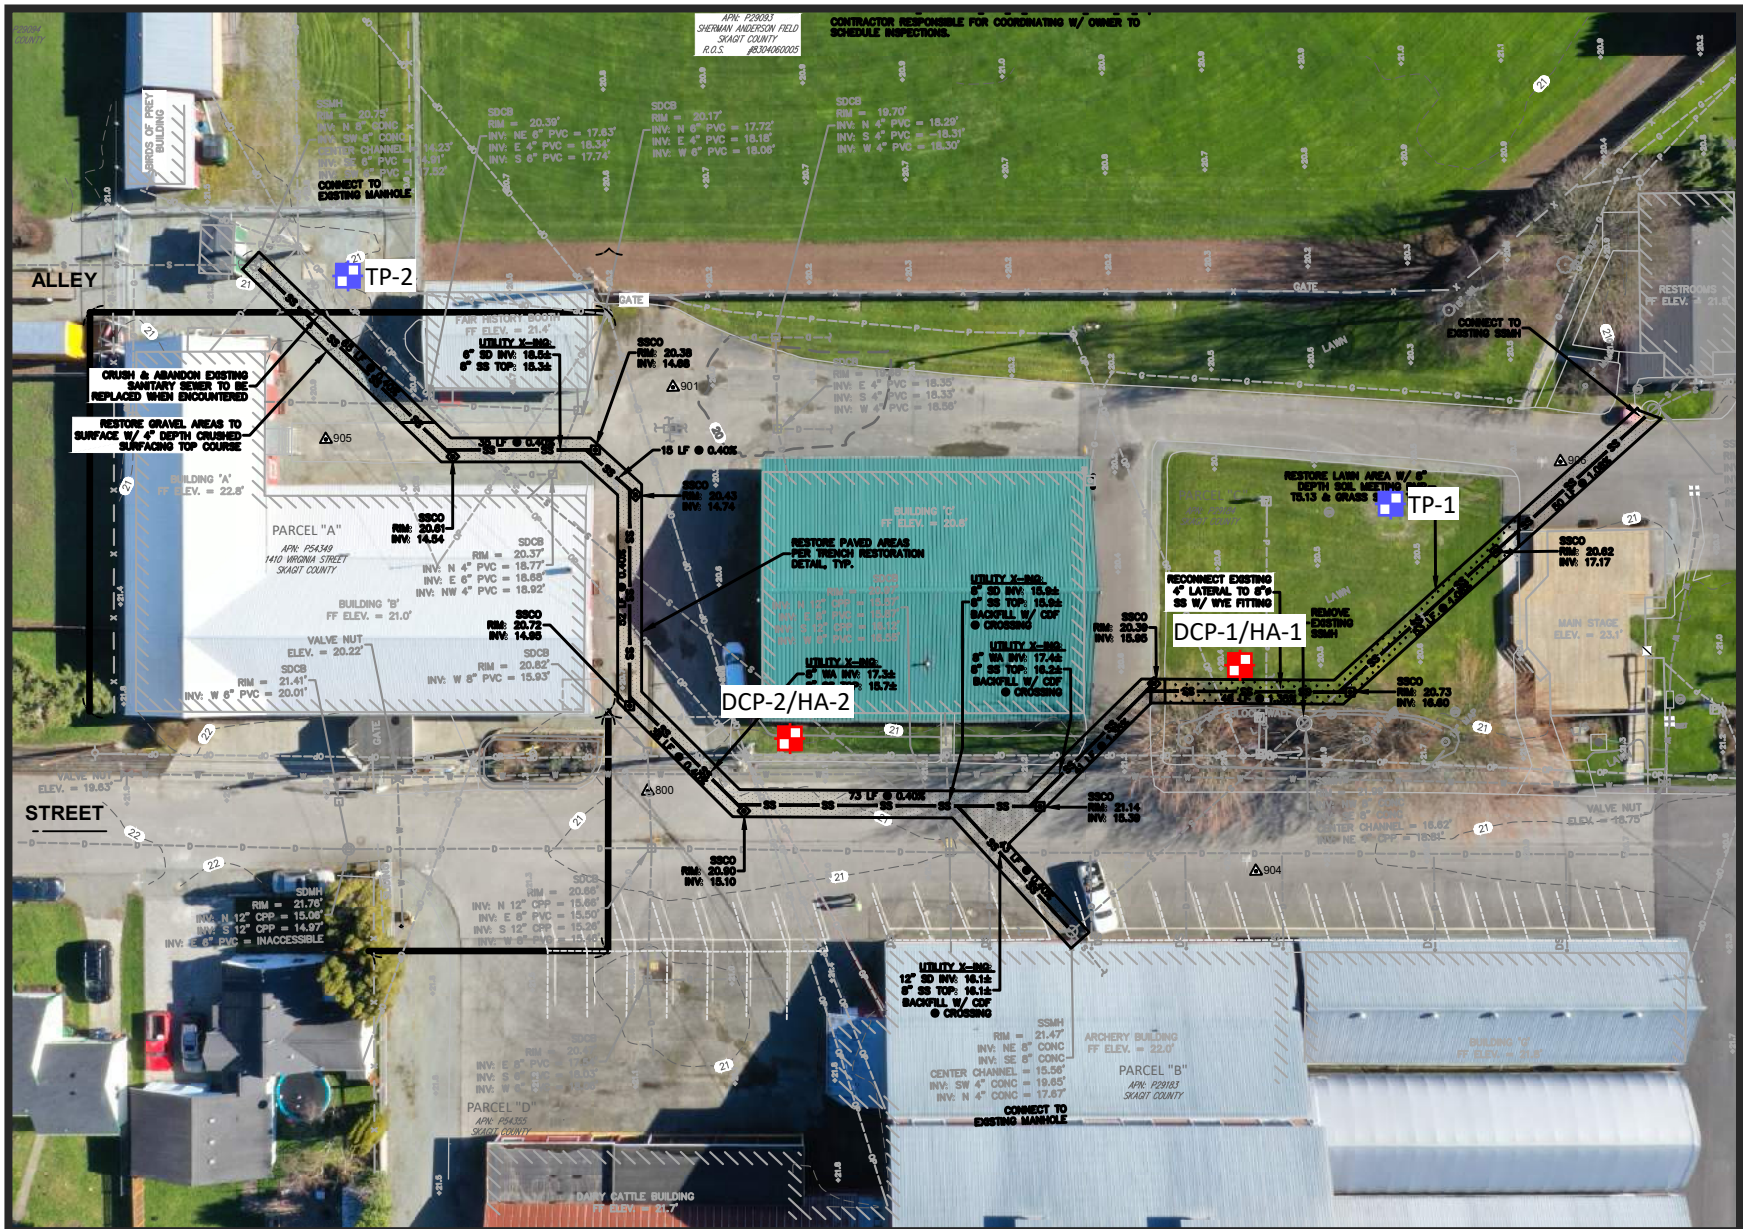
MAP REFERENCE Preliminary Sewer Plan by Freeland & Associates dated 02-06-2024 overlaying overhead photo taken with Mavic II Pro drone on 02-16-2024

■ = Approximate Test Pit Location  
■ = Approximate Dynamic Cone Penetrometer/Hand Auger Location
